Town of Westlake

1 Million Gallon Ground

August 9, 2023

**INSPECTION REPORT #2
1 MILLION GALLON GROUND
“BIG ONE”
TOWN OF WESTLAKE, TX**

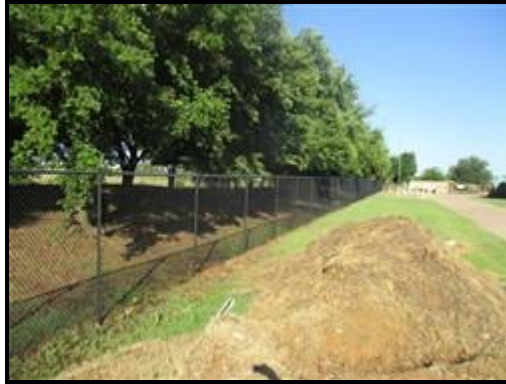
Security Fence:

This facility is surrounded by an 8-foot chain link and barbed wire security fence that was in good condition at the time of inspection. No abnormalities were reported.

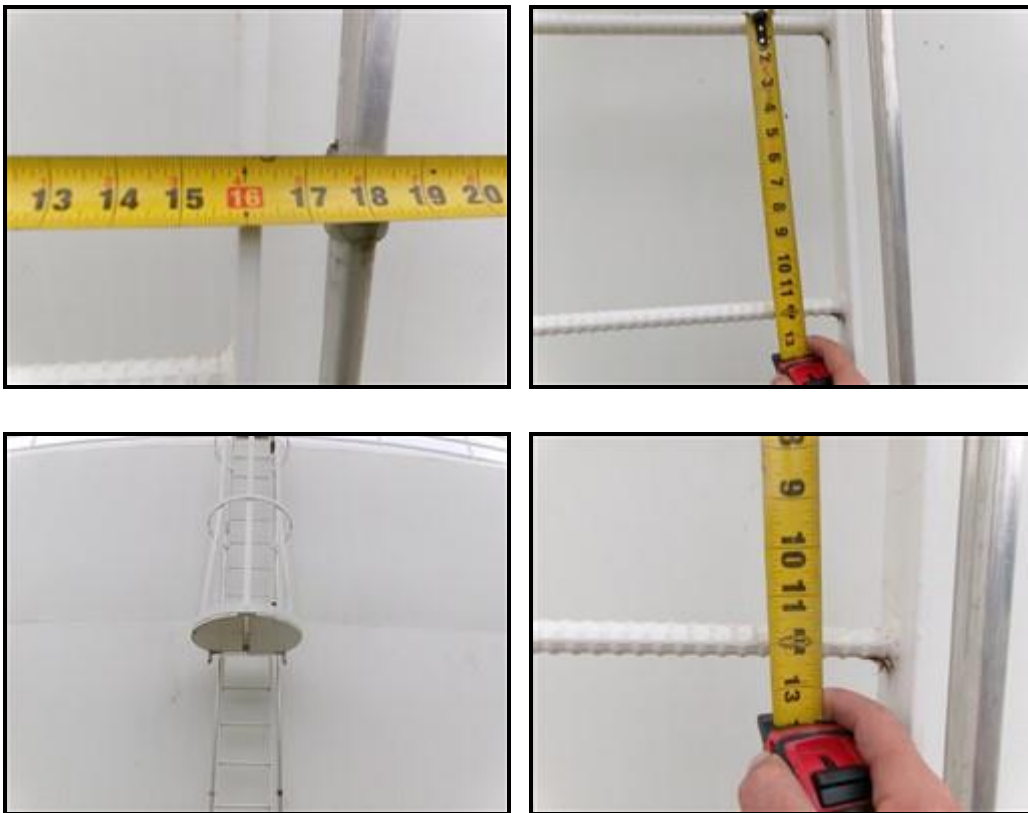
External Ladder:

The external ladder was in good condition. It measures 16 inches in width and has rebar $\frac{3}{4}$ inch rungs with 1 foot spacing. The ladder is equipped with a 34 inch in diameter cage for fall protection that was also in good condition. No abnormalities were reported.

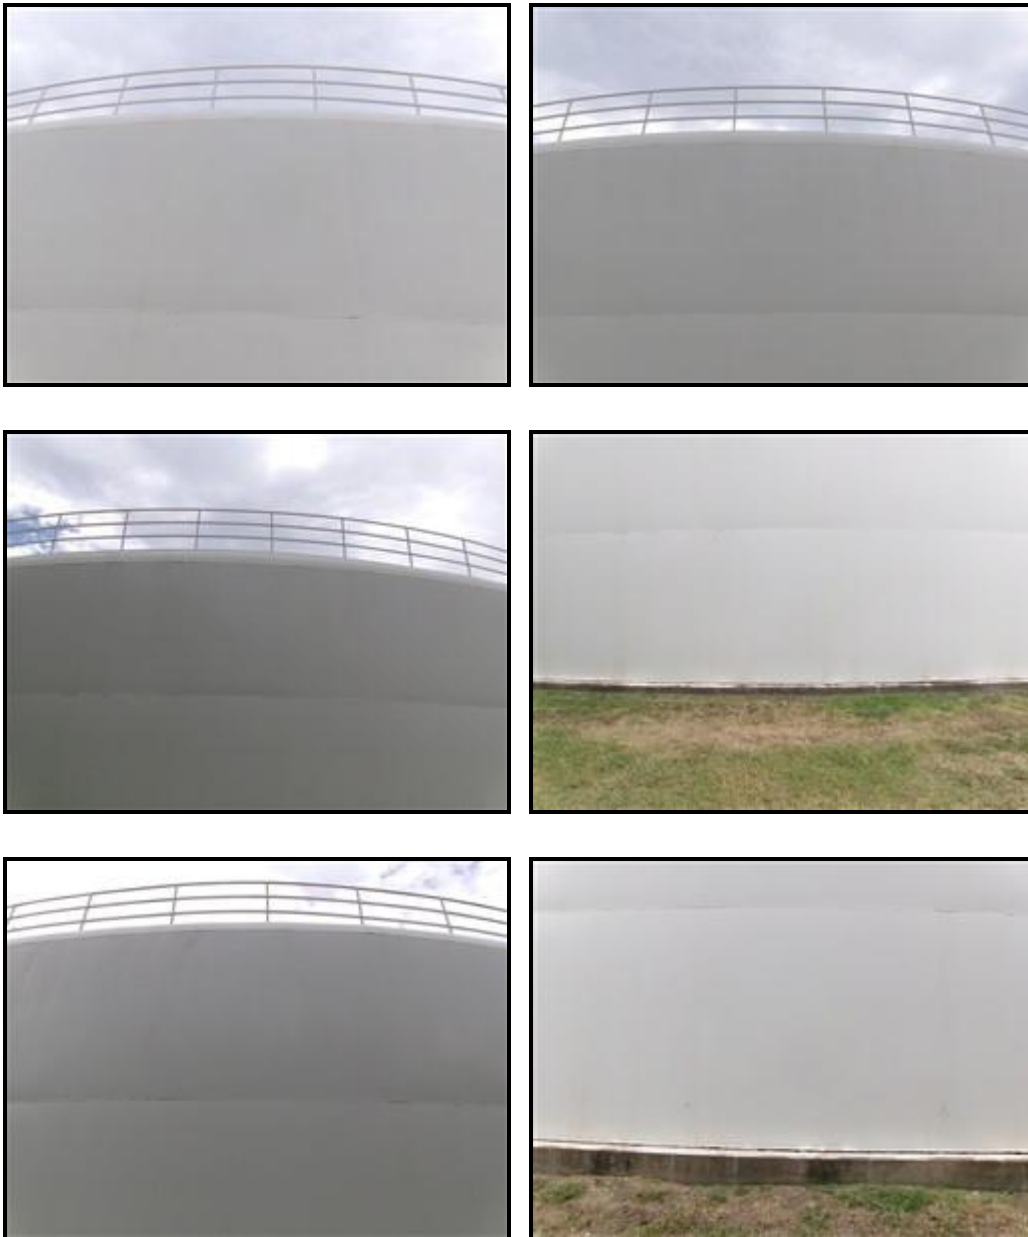
External Sidewall Plates:

The external sidewall plates were in good condition at the time of inspection. Light staining was reported. No other abnormalities were reported.

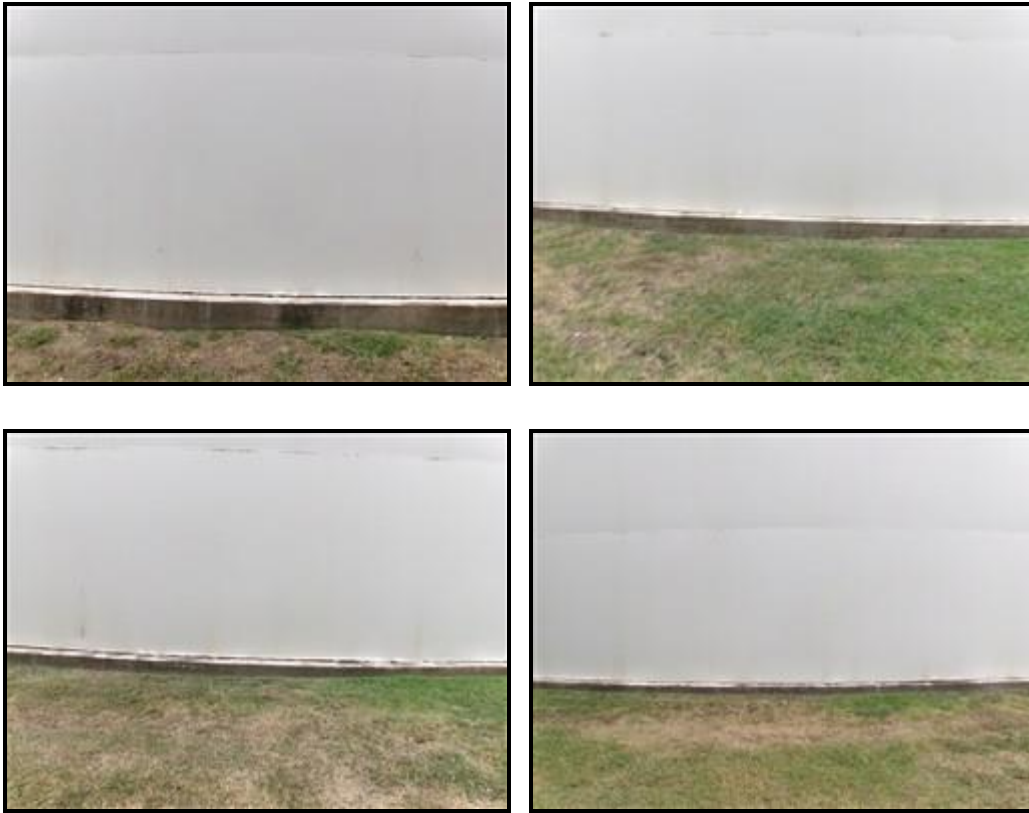
Foundation:

This facility rests on a concrete foundation that was in good condition at the time of the inspection.

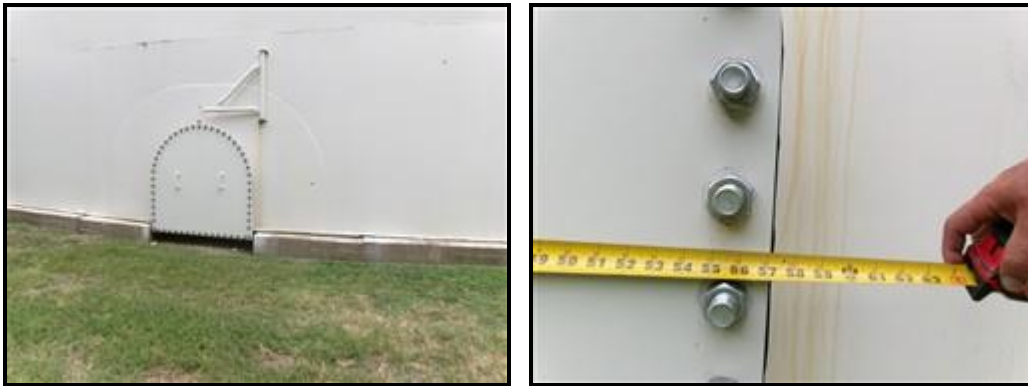
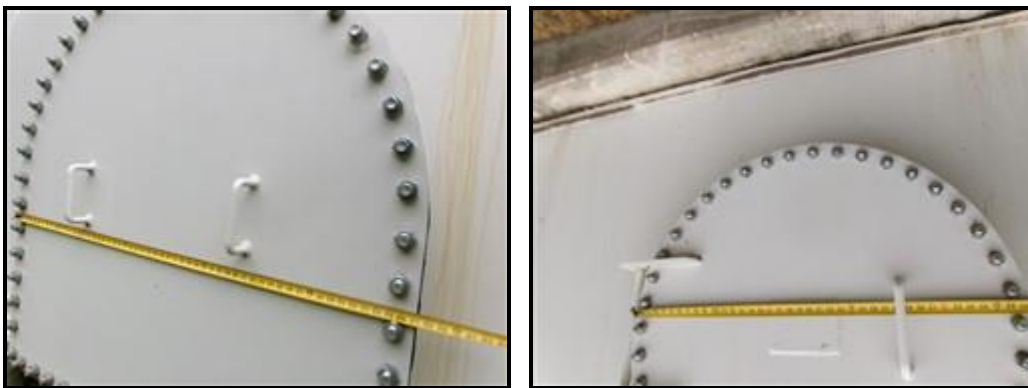
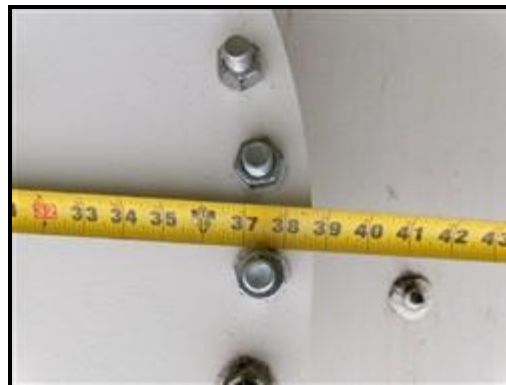
Manway Access Hatch:

The two manway access hatches were in good condition at the time of inspection. The gaskets were intact, and no leaking was observed. One measured 38 inches and the other one measured 57 inches. Neither hatch was labeled as a “Confined Space” entry. **TEXAS TANK SERVICES** recommends installing “Confined Space” entry placards to the two manway access hatches.

3. Add “Confined Space Entry” placards to the water access hatch, and both manway access hatches.
4. Add and enlarge the ventilation structure due to the heavy amount of condensation currently accumulating within the facility to extend the life of this facility.

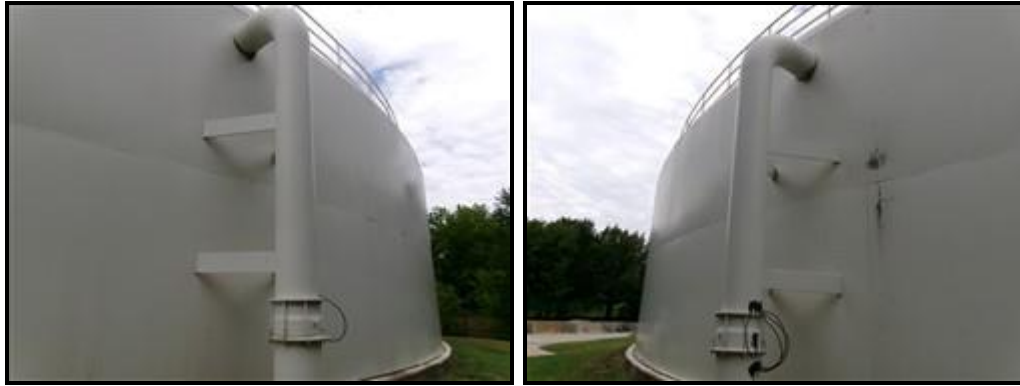
Water Inlet:

The water inlet was in good condition at the time of inspection. It is located at the five o' clock position of the facility. No abnormalities were reported.

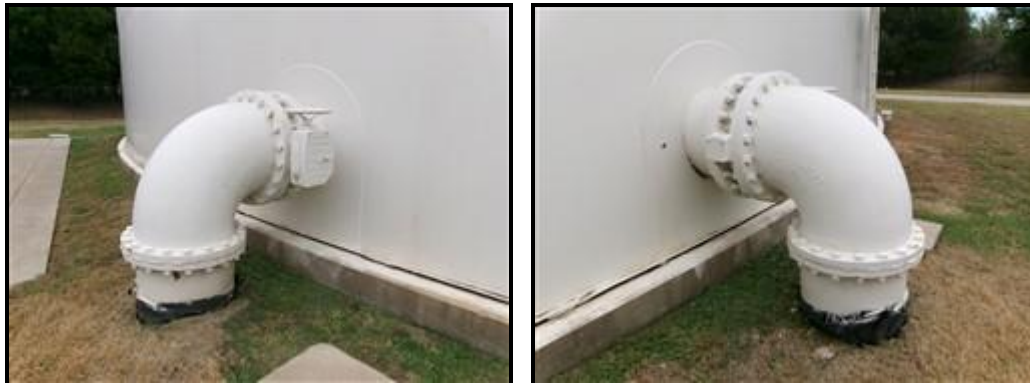
Water Outlet:

The water outlet was in good condition at the time of inspection. It is located at the one o' clock position of the facility. Light staining was reported. No other abnormalities were reported.

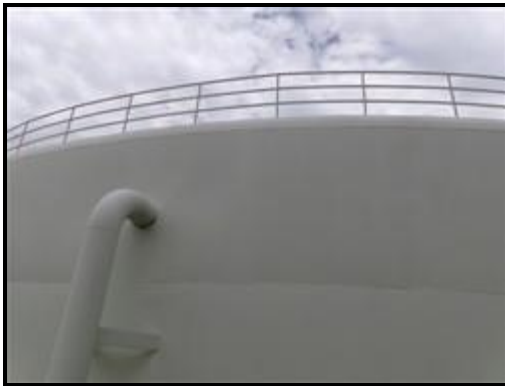
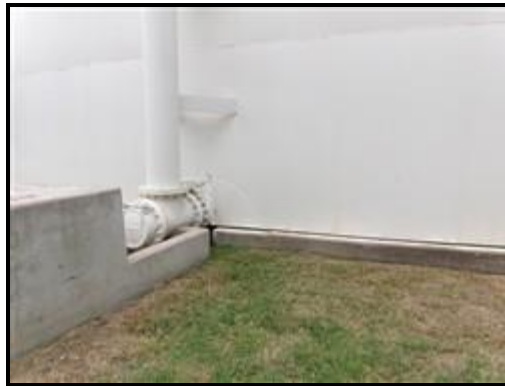
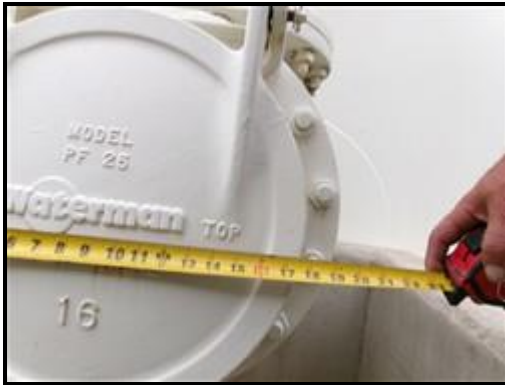
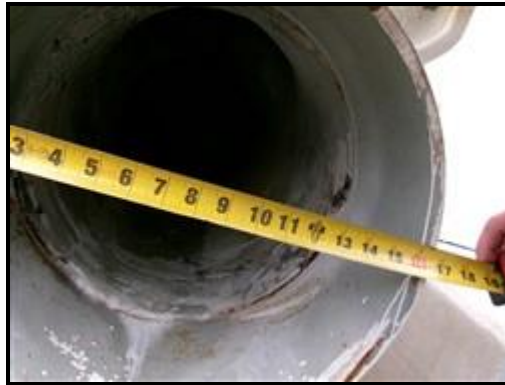
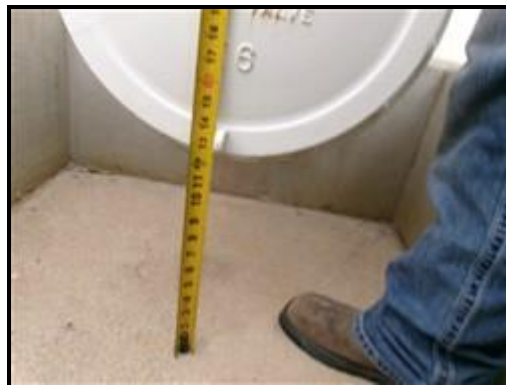
Overflow Pipe and Flapper:

The overflow pipe and flapper were in good condition at the time of inspection. It is located at the seven o' clock position of the facility. The pipe measures 16 inches in diameter and discharges 12 inches off the ground. The flapper measures 18 inches in diameter and maintains a good seal. Light corrosion was reported. No other abnormalities were reported.

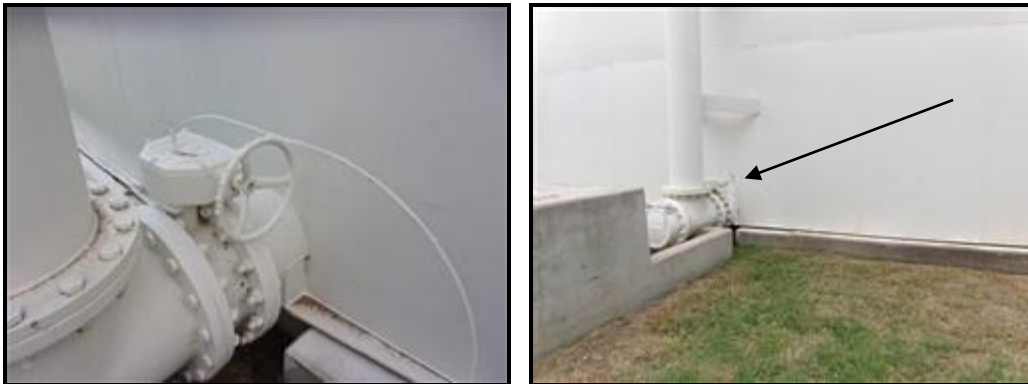
Manual Drain:

The manual drain was in good condition at the time of inspection. It is located at the eight o'clock position of the facility. Light staining was noted, No other abnormalities were reported.

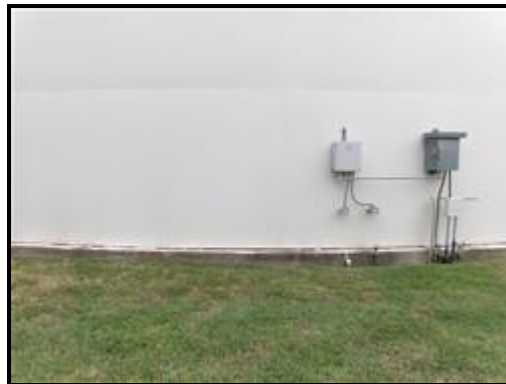
Water Level Indicator:

The electronic water level indicator was operable and in good condition at the time of inspection. No abnormalities were reported.

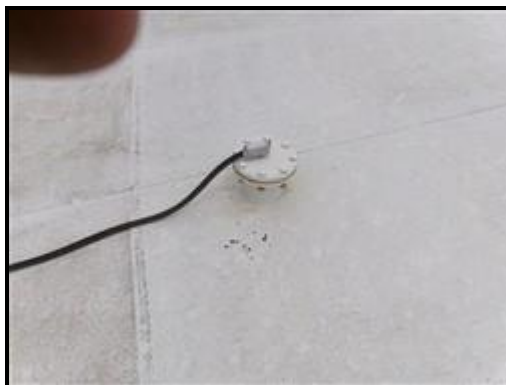
Anode Covers:

The one anode cover was in good condition at the time of inspection. No abnormalities were reported.

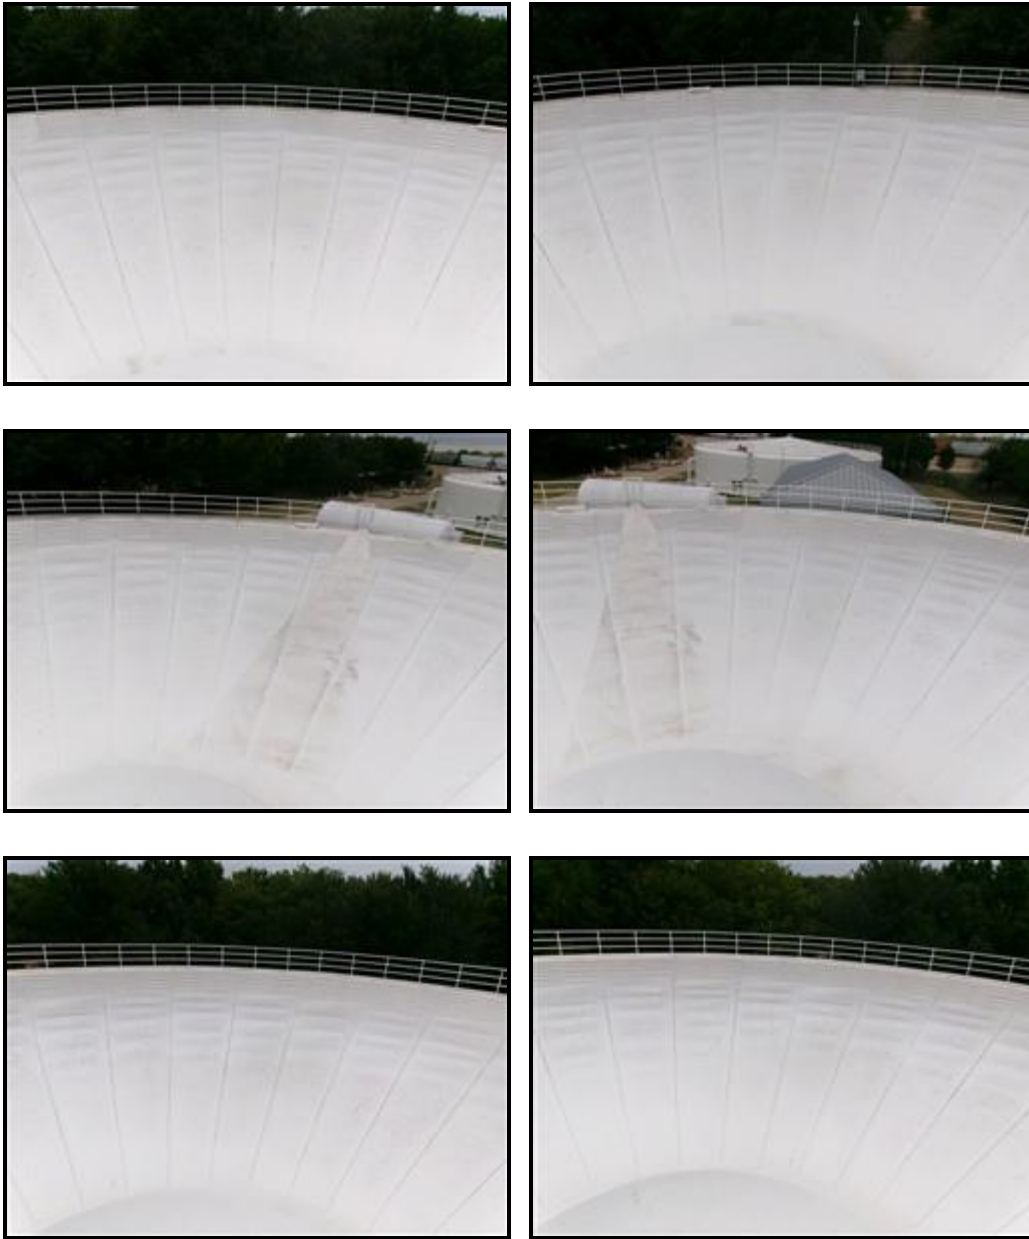
External Roof Plates:

The external roof plates were in good condition at the time of inspection. Light staining and thinning of the protective coating were reported. No other abnormalities were reported..

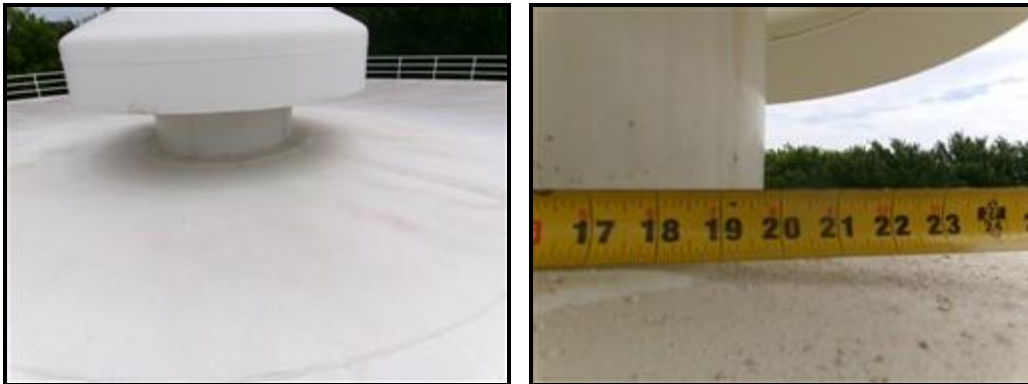
Roof Ventilation Structure:

The mushroom shaped roof ventilation structure was in good condition. It is located in the center of facility on the roof plates and measures 20 inches in diameter. It is equipped with a 16-mesh screen that is also in good condition. No abnormalities were reported.

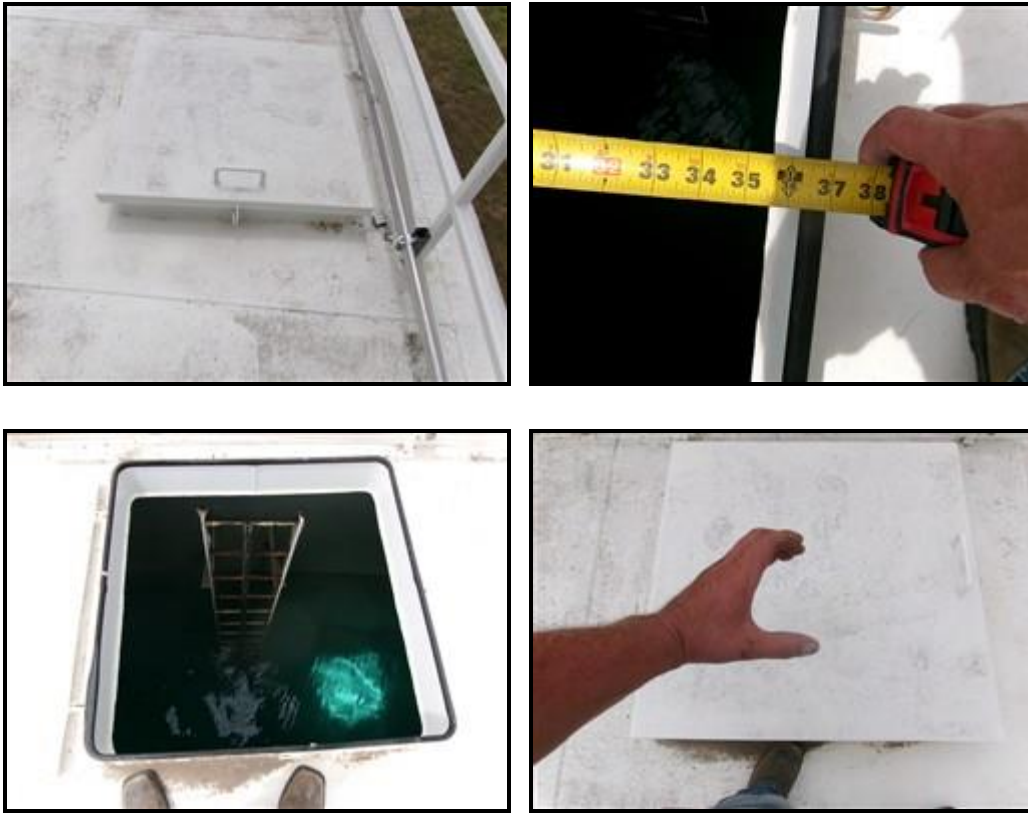
Water Access Hatch:

The water access hatch was in good condition. It is located at the twelve o’ clock position of the facility on the roof plates and measures 36 x 36 inches. The hatch was secured with a combination lock upon the arrival of the inspection crew. However, it was not labeled as a “Confined Space” entry. Light atmospheric staining was reported. **TEXAS TANK SERVICES** recommends installing a “Confined Space” entry placard to the water access hatch.

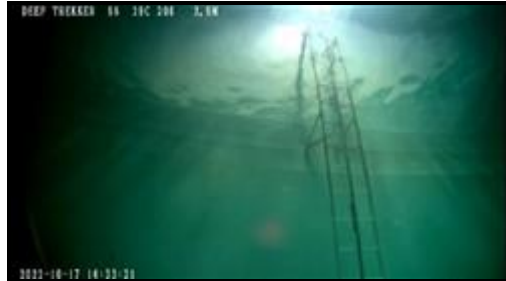
Water Access Hatch:

The water access hatch was in good condition upon internal inspection. Light staining was reported. No other abnormalities were reported.

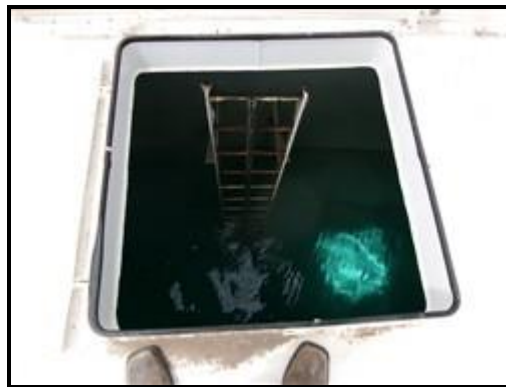
Water Access Ladder:

The water access ladder was in fair to poor condition above the water line. It measures 16 inches in width and has round $\frac{3}{4}$ inch rungs with 1 foot spacing. The ladder is t equipped with a cable style fall protection. Heavy corrosion was reported on the ladder and fall protection. **TEXAS. TEXAS TANK SERVICES** recommends machine prepping the corroded areas of the water access ladder and fall protection and adding a new protective coating.

5. Machine prep the corroded areas of the water access ladder and fall protection and adding a new protective coating.
6. Monitor the center support columns and roof plates for increased corrosion and possible machine prep and recoat in the future.

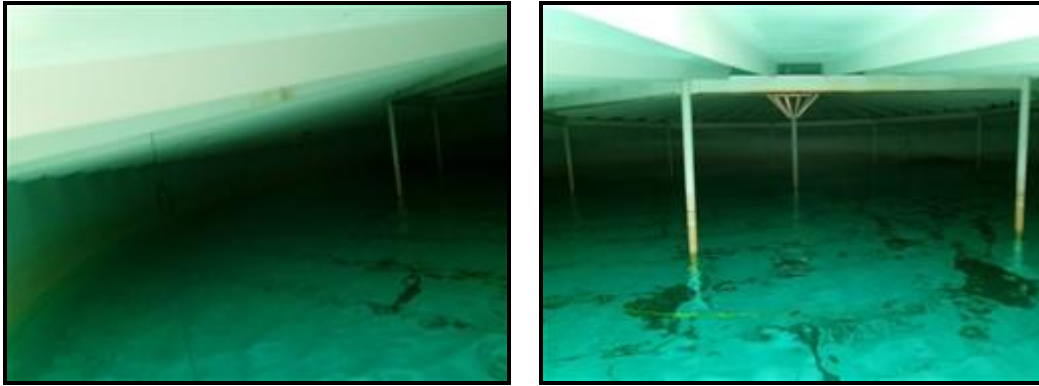
Internal Sidewall Plates:

The internal sidewall plates were in good condition above the water line. Light staining was reported. No other abnormalities were reported.

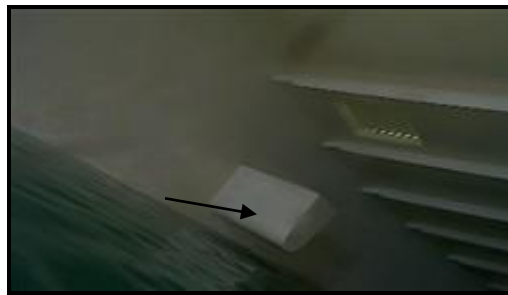
Overflow Flume:

The overflow flume was in good condition at the time of inspection. It measures 3 ft x 3 ft. Light staining was reported. No other abnormalities were reported.

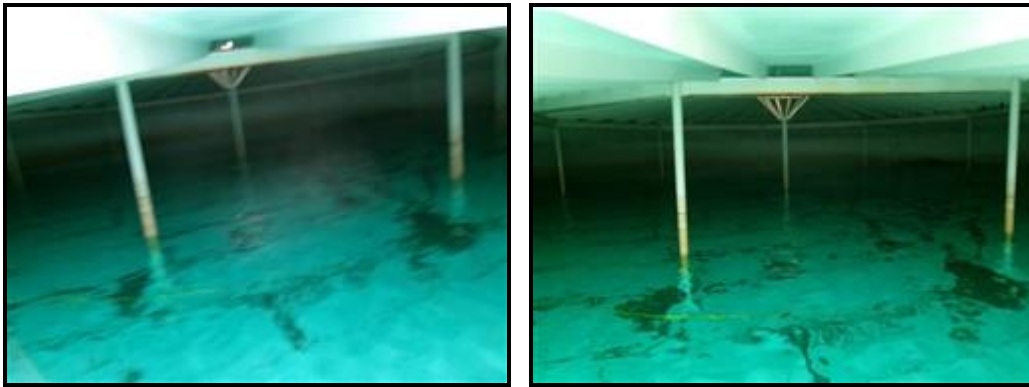
Support Columns:

The support columns were in good condition above the water line. Light staining and corrosion were reported. No other abnormalities **TEXAS TANK SERVICES** recommends monitoring the support columns for increased corrosion and possible machine prep and recoat in the future. were reported.

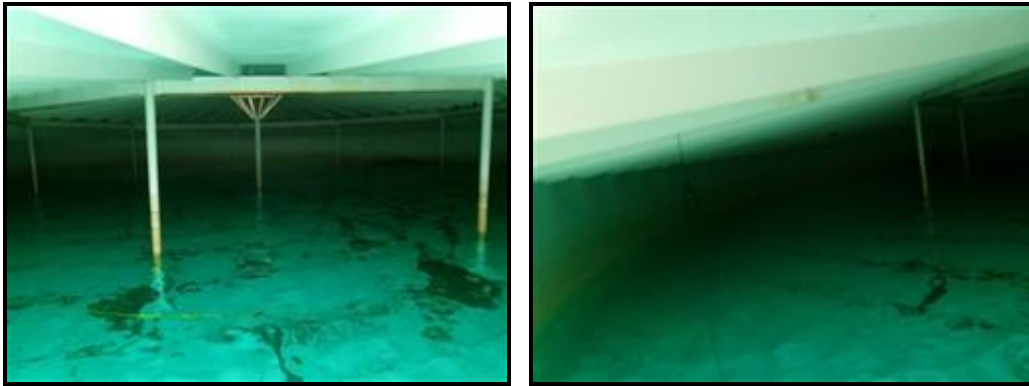
Internal Roof Plates:

The internal roof plates were in good condition. Light condensation and corrosion were reported. **TEXAS TANK SERVICES** recommends adding and enlarging the ventilation structure due to the heavy amount of condensation currently accumulating within the facility. **TEXAS TANK SERVICES** recommends monitoring the internal roof plates for increased corrosion and possible machine prep and recoat in the future.

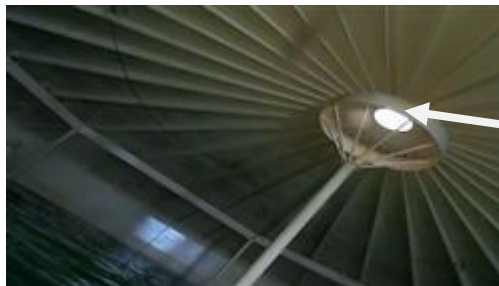
Roof Ventilation Structure:

The roof ventilation structure was in good condition upon internal inspection. It is located in the center of the facility on the roof plates and measures 20 inches in diameter. It is equipped with a 16-mesh screen that is also in good condition. No abnormalities were reported. **TEXAS TANK SERVICES** recommends adding and enlarging the ventilation structure due to the heavy amount of condensation currently accumulating within the facility.

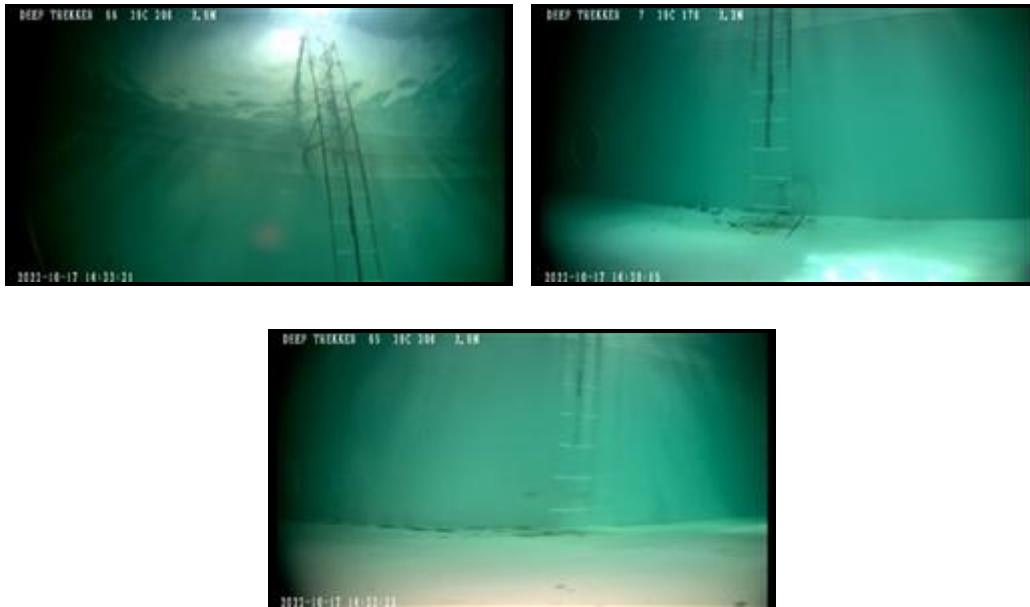
Water Access Ladder (below the water line):

The water access ladder was in fair condition below the water line. It measures 16 inches in width and has round $\frac{3}{4}$ inch rungs with 1 foot spacing. The ladder is equipped with a cable style fall protection. Moderate staining and corrosion were reported. **TEXAS TANK SERVICES** also recommends performing a chemical power wash of the interior of the facility, utilizing Blue Earth Labs' product Floran, to remove staining and extend the life of this structure. **TEXAS TANK SERVICES also recommends** machine prepping the corroded areas of the water access ladder and adding a new protective coating.

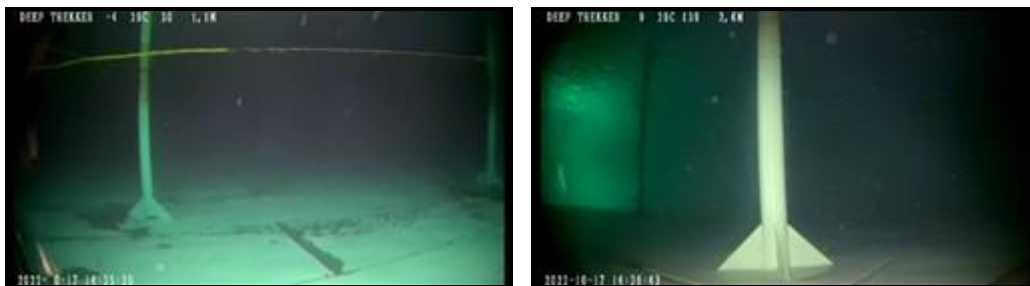
Support Columns:

The support columns were in good condition below the water line. Moderate staining was reported. **TEXAS TANK SERVICES** recommends performing a chemical power wash of the interior of the facility, utilizing Blue Earth Labs' product Floran, to remove staining and extend the life of this structure.

7. Perform a chemical power wash of the interior of the facility, utilizing Blue Earth Labs’ product Floran, to remove staining and extend the life of this structure.

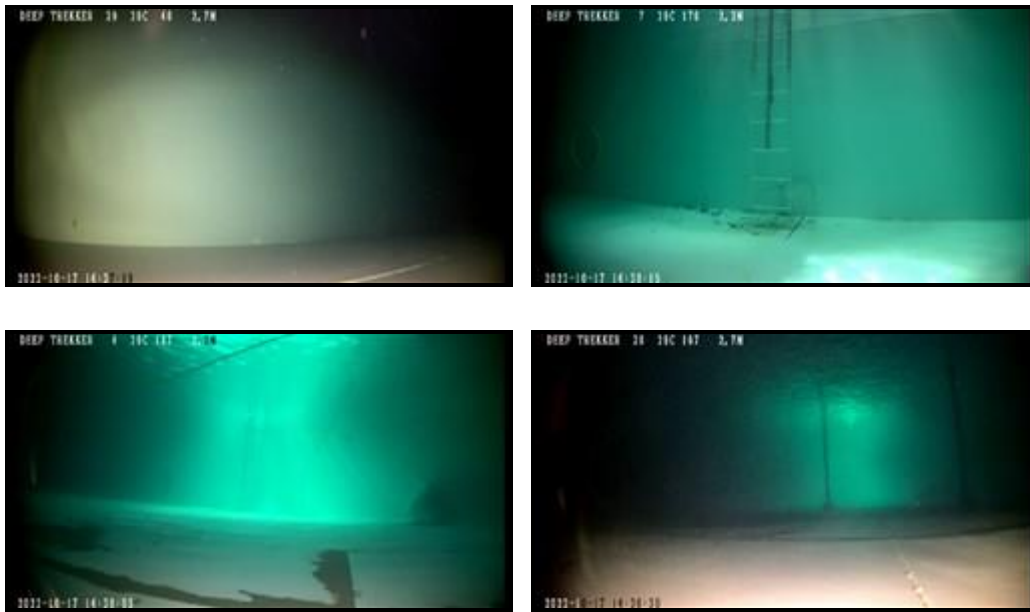
Internal Sidewall Plates:

The internal sidewall plates were in good condition below the water line. Light staining was reported. No other abnormalities were reported. **TEXAS TANK SERVICES** recommends performing a chemical power wash of the interior of the facility, utilizing Blue Earth Labs' product Floran, to remove staining and extend the life of this structure.

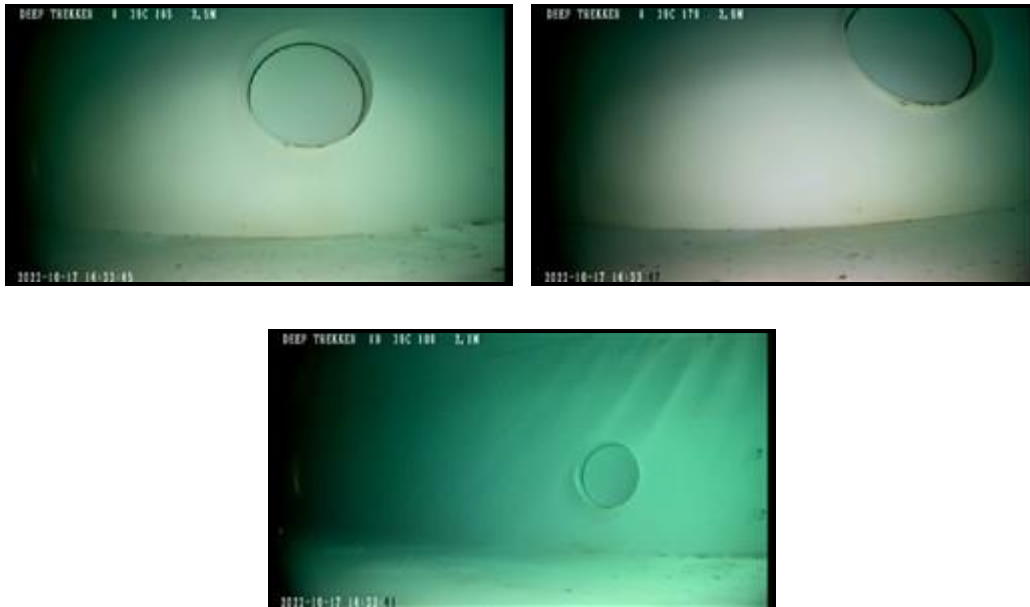
Manway Access Hatches:

The two manway access hatches were in good condition at the time of inspection. They are located at the eleven and four o' clock positions of the facility. The gaskets were intact, and no leaking was observed. Light staining was reported. No other abnormalities were reported.

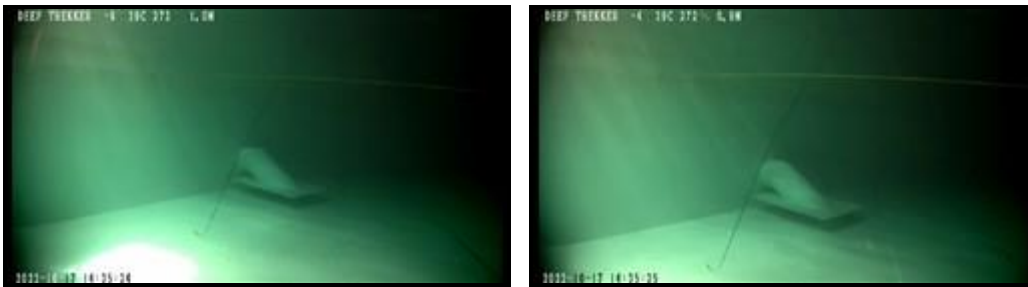
Water Outlet:

The water outlet was in good condition at the time of inspection. Light staining was reported. No other abnormalities were reported.

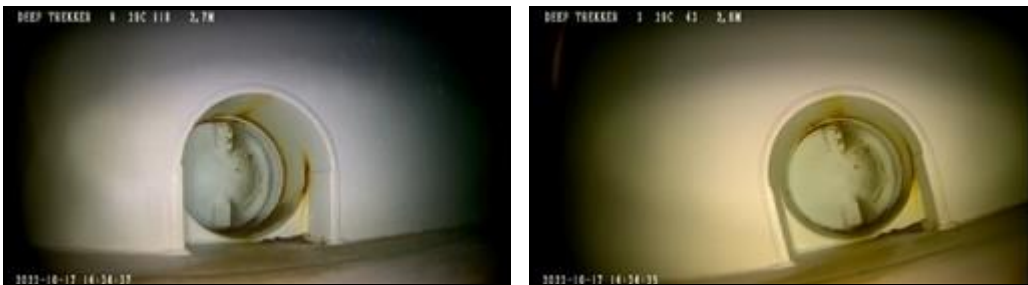
Manual Drain:

The manual drain was in good condition. Light staining and corrosion were reported. **TEXAS TANK SERVICES** recommends performing a chemical power wash of the interior of the facility, utilizing Blue Earth Labs' product Floran, to remove staining and extend the life of this structure.

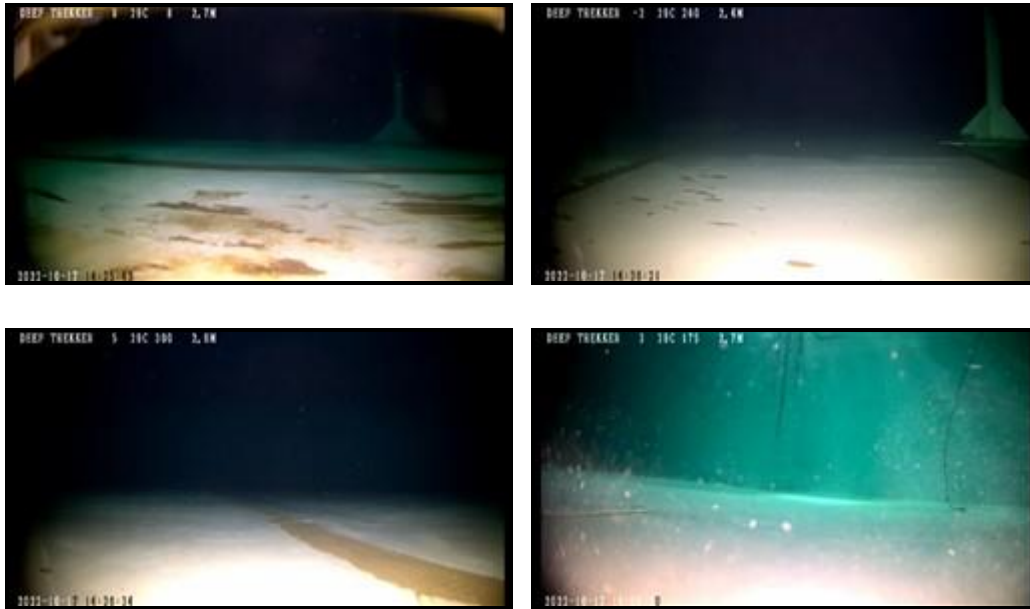
Internal Floor Plates:

The internal floor plates were in good condition at the time of inspection. Light to moderate staining was reported. No other abnormalities were reported. **TEXAS TANK SERVICES** recommends performing a chemical power wash of the interior of the facility, utilizing Blue Earth Labs' product Floran, to remove staining and extend the life of this structure.

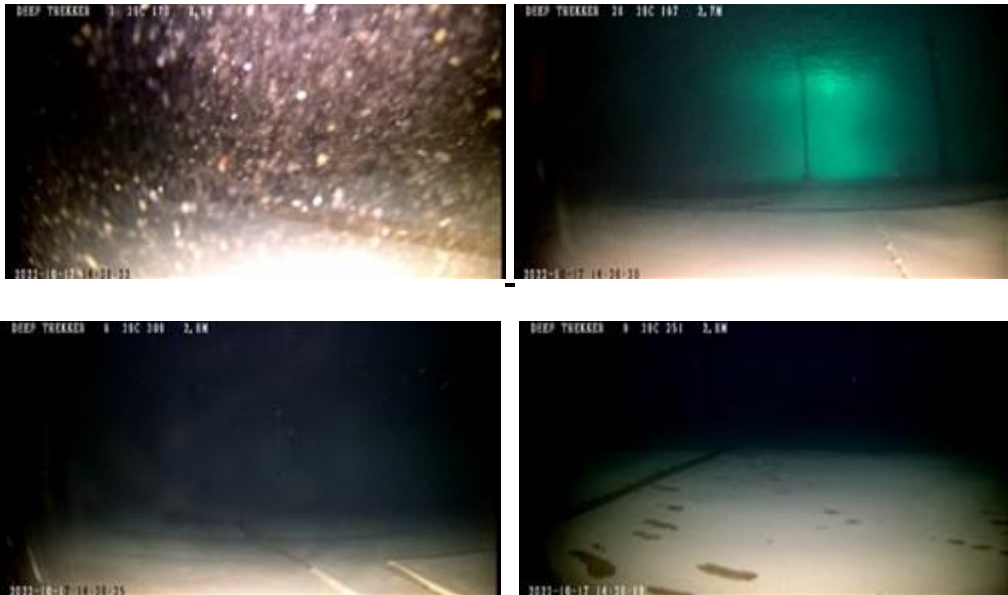
Sediment Depth:

The sediment depth was reported as heavy dusting. **TEXAS TANK SERVICES** recommends an in-service cleaning to remove this sediment in order to better evaluate the floor plates, as well as improve the quality of the water in this tank.

2. Perform an in-service cleaning to remove this sediment in order to better evaluate the floor plates, as well as improve the quality of the water in this tank.
