Town of Westlake

685 Thousand Gallon Ground

“Denton Highway”

**INSPECTION REPORT #1
685 THOUSAND GALLON GROUND
“DENTON HIGHWAY”
TOWN OF WESTLAKE, TEXAS**

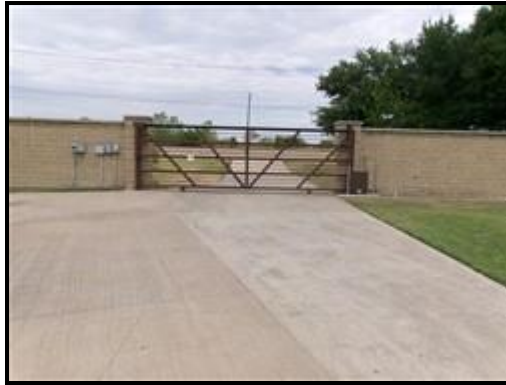
Security Fence:

This facility is surrounded with a 8 foot chain link security fence that was in good condition at the time of inspection. No abnormalities were reported.

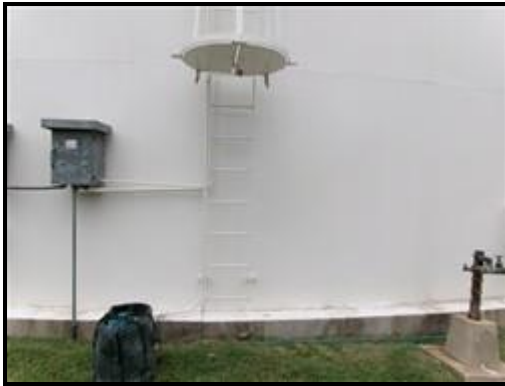
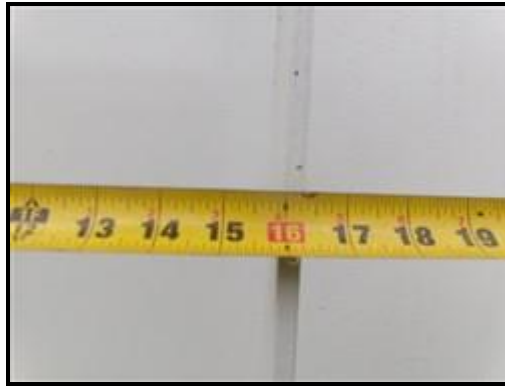
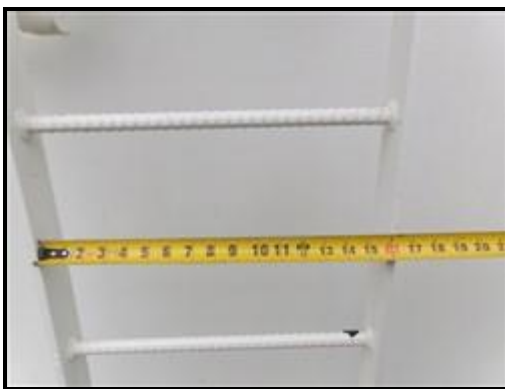
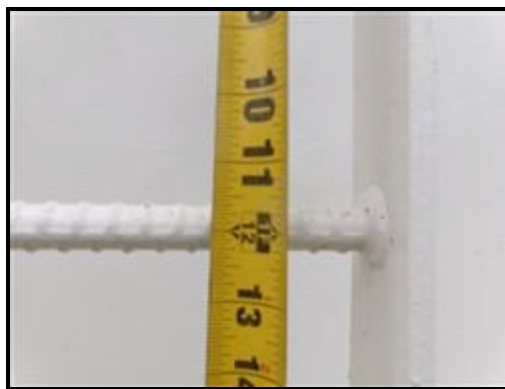
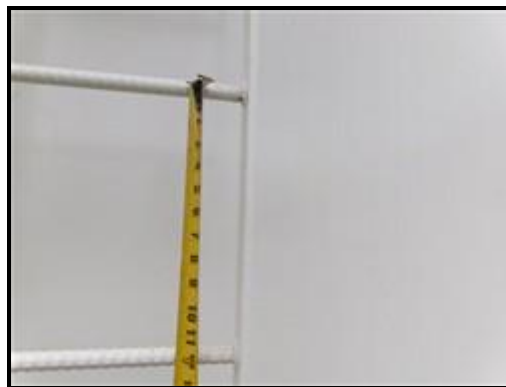
External Ladder:

The external ladder was in good condition. It measures 16 inches in width and has round $\frac{3}{4}$ inch rungs with 1 foot spacing. The ladder is equipped with a 36 inch in diameter cage for fall protection that was also in good condition. No abnormalities were reported.

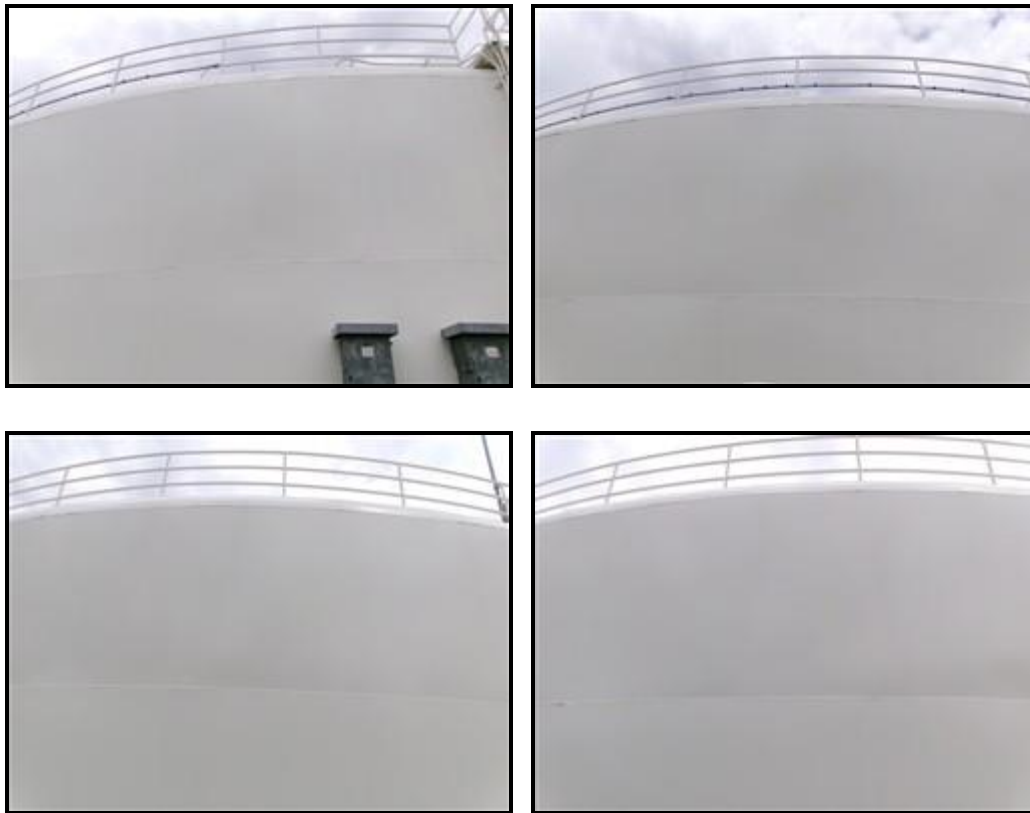
External Sidewall Plates:

The external sidewall plates were in good condition at the time of inspection. No abnormalities were reported.

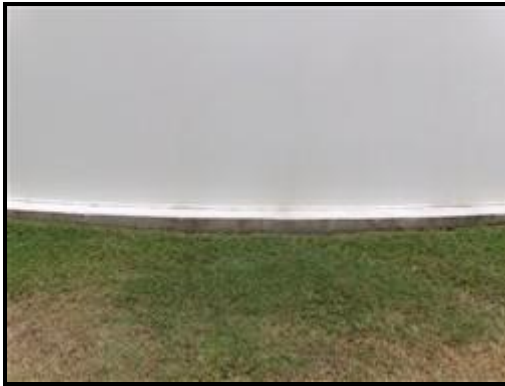
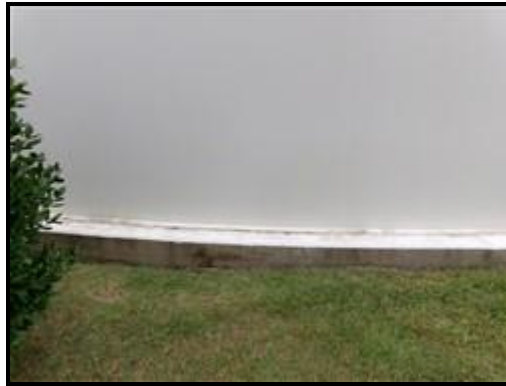
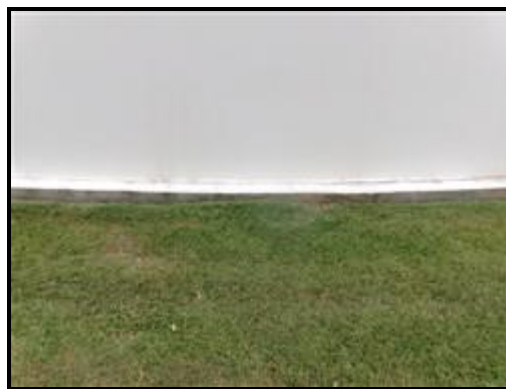
Foundation:

This facility rests on a concrete foundation that was in good condition at the time of the inspection.

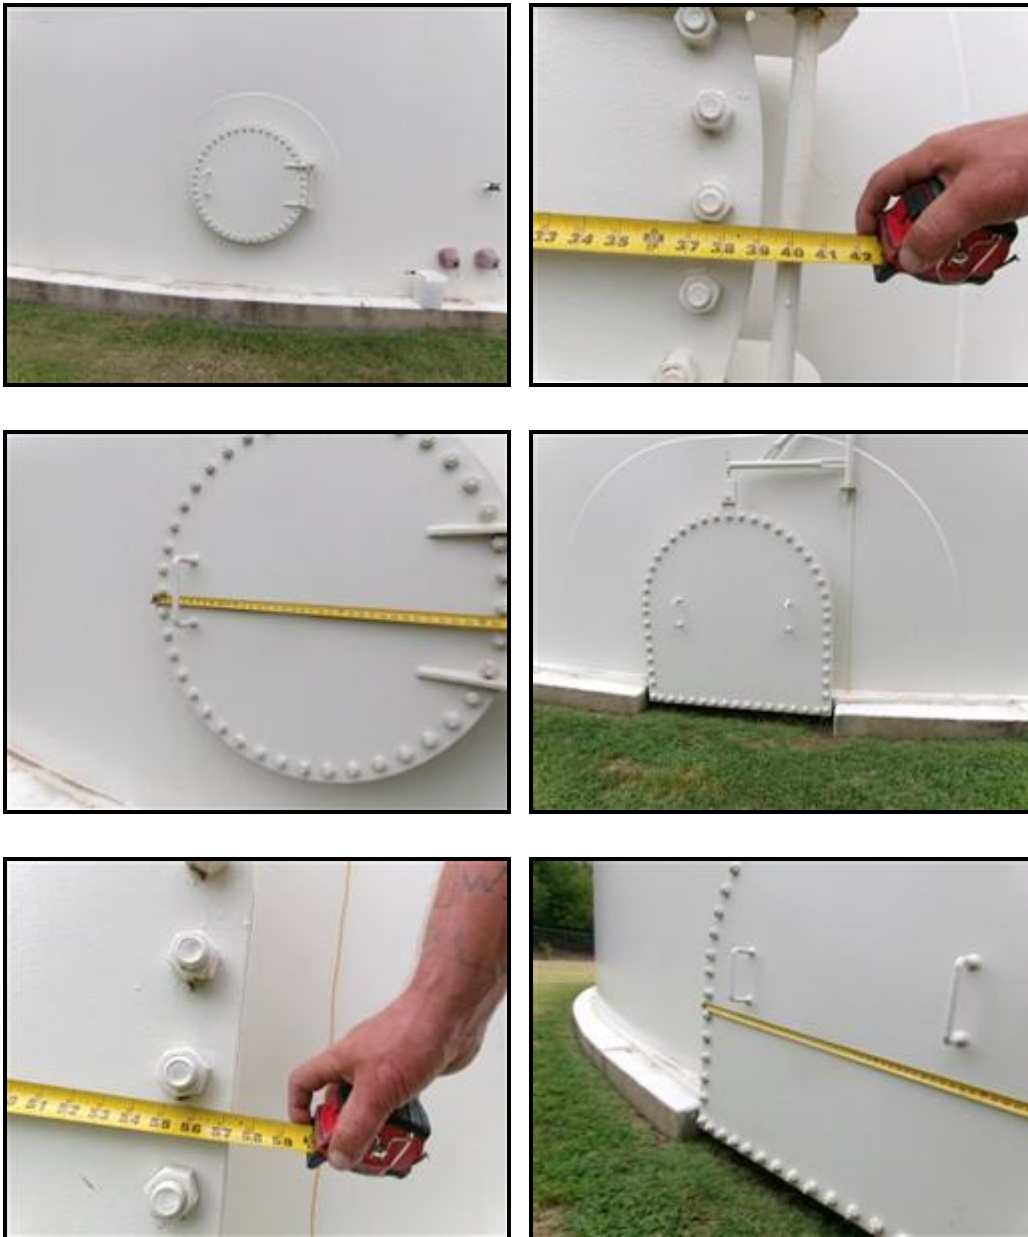
Manway Access Hatches:

The two manway access hatches were in good condition at the time of inspection. The gaskets were intact, and no leaking was observed. One measures 57 inches and the other measures 39 inches. Neither of the hatches were labeled as “Confined Space” entries. **TEXAS TANK SERVICES** recommends installing a “Confined Space” entry placard to the manway access hatches.

3. Add “Confined Space Entry” placards to the water access hatch, two manway access hatches and overflow burst disk.
4. Install fall protection to the water access ladder to insure the safety of anyone accessing this component.

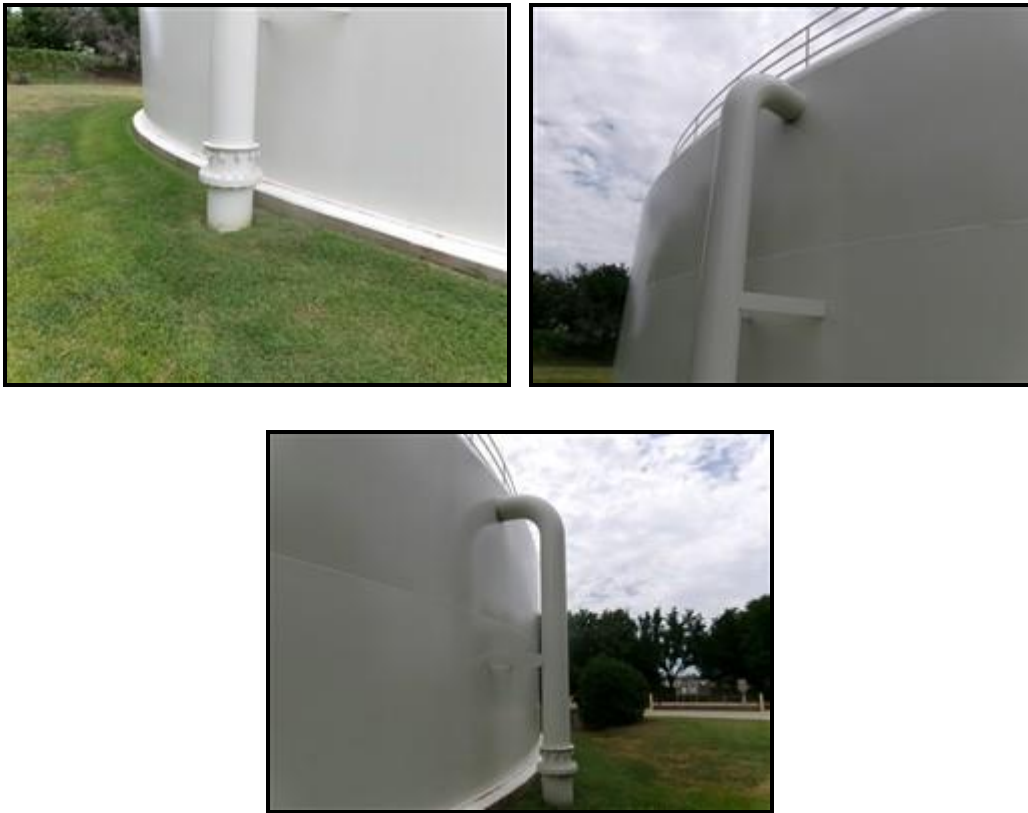
Water Inlet:

The water inlet was in good condition at the time of inspection. No abnormalities were reported.

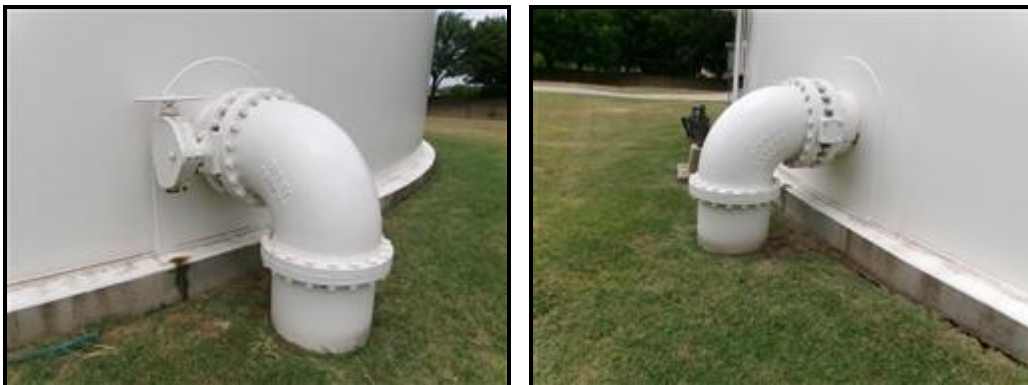
Water Outlet:

The water outlet was in good condition at the time of inspection. It is located at the eleven o' clock position of the facility. No abnormalities were reported.

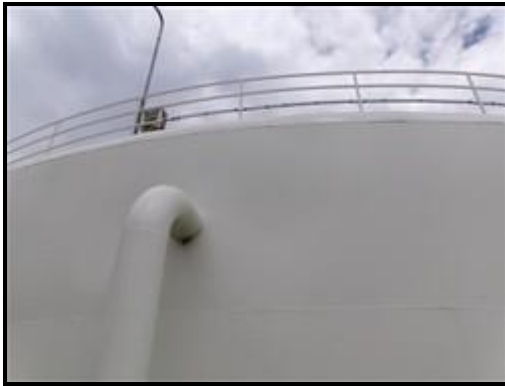
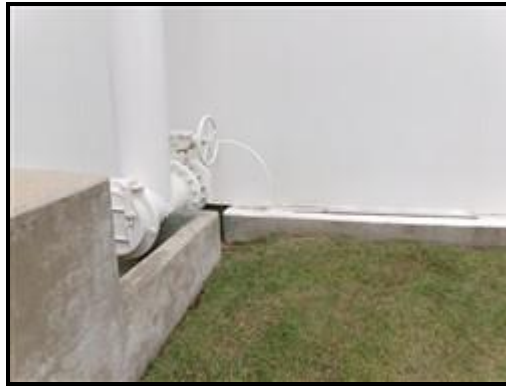
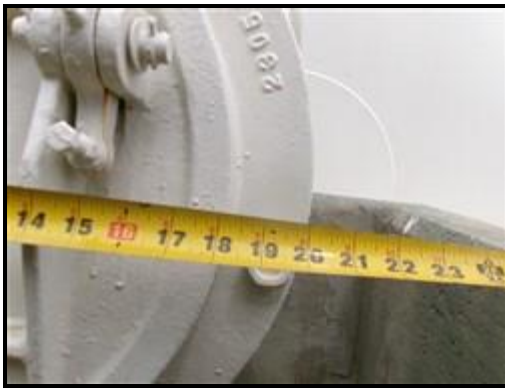
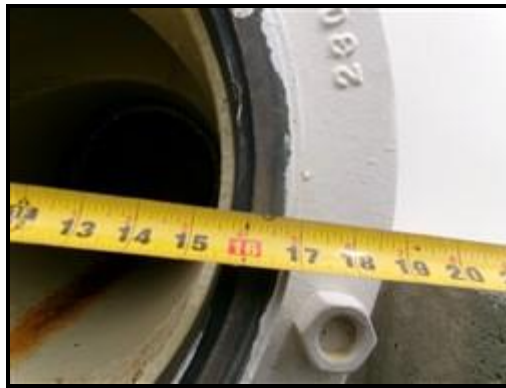
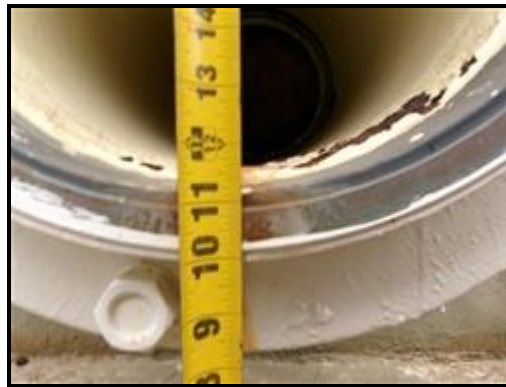
Overflow Pipe and Flapper:

The overflow pipe and flapper were in good condition. They are located at the three o' clock position of the facility. The pipe measures 16 inches in diameter and discharges 11 inches off the ground. The flapper measures 18 ½ inches. Light staining was reported inside of the pipe. No other abnormalities were reported.

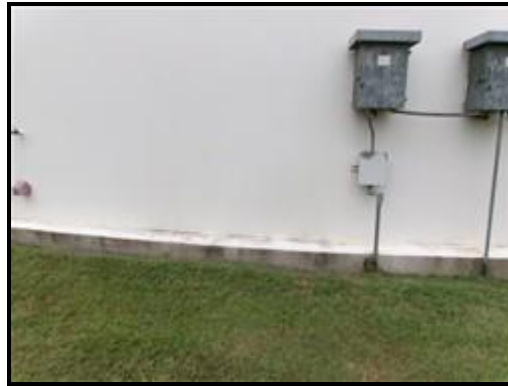
Water Level Indicator:

The electronic water level indicator was operable and in good condition at the time of inspection. It is located at the twelve o' clock position of the facility. No abnormalities were reported.

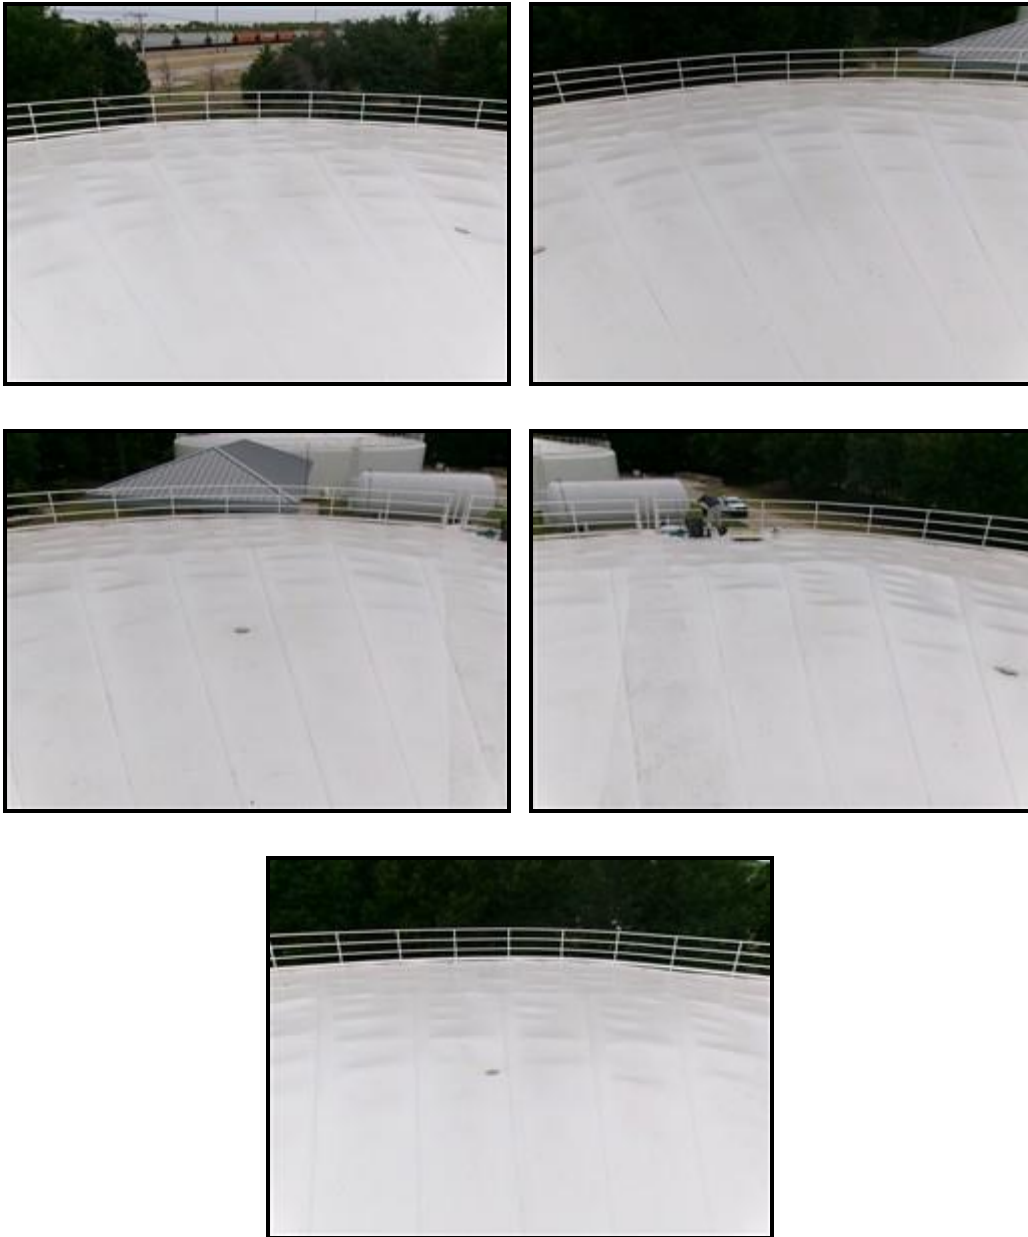
External Roof Plates:

The external roof plates were in good condition at the time of inspection. Light staining was noted. No other abnormalities were reported.

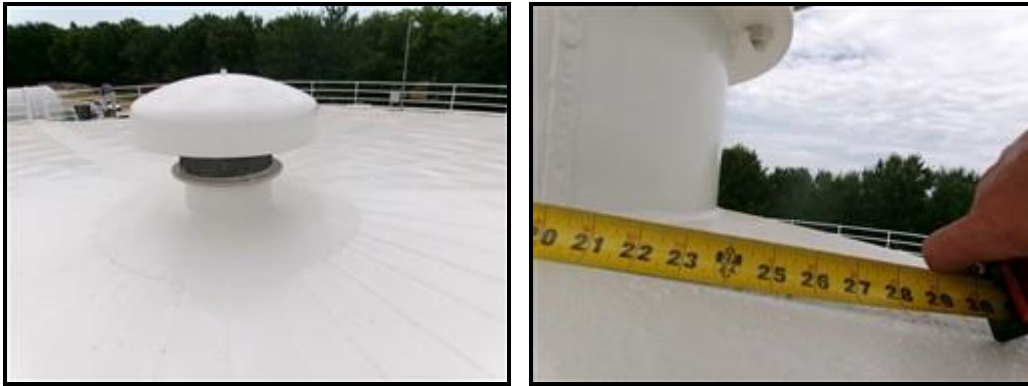
Roof Ventilation Structure:

The mushroom shaped roof ventilation structure was in good condition. It is located in the center of facility on the roof plates and measures 22 inches in diameter. It is equipped with a 16-mesh screen that is also in good condition. No abnormalities were reported.

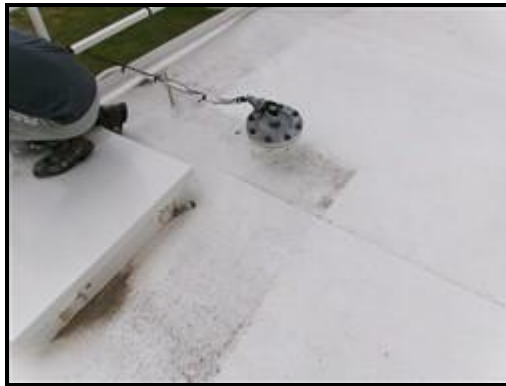
Anode Cover:

The one anode cover was in good condition. No abnormalities were reported.

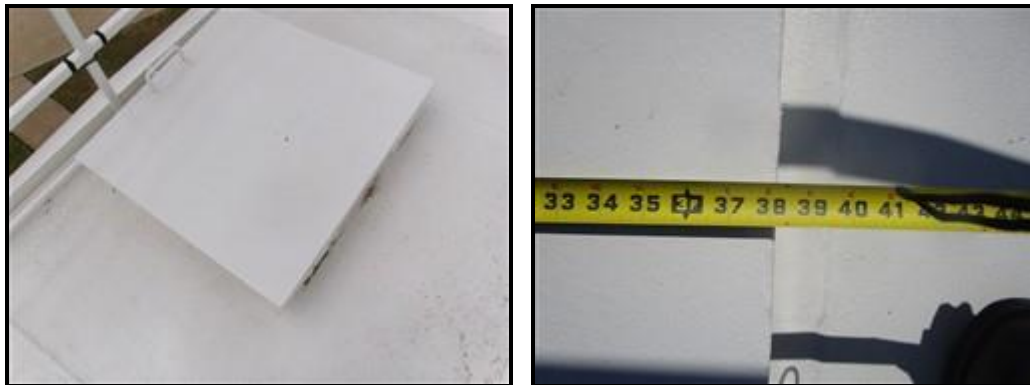
Overflow Burst Disc:

The overflow burst disc was in good condition. It measures 38 inches. The burst disc was not labeled as a “Confined Space” entry. **TEXAS TANK SERVICES** recommends installing a “Confined Space” entry placard to the overflow burst disc.

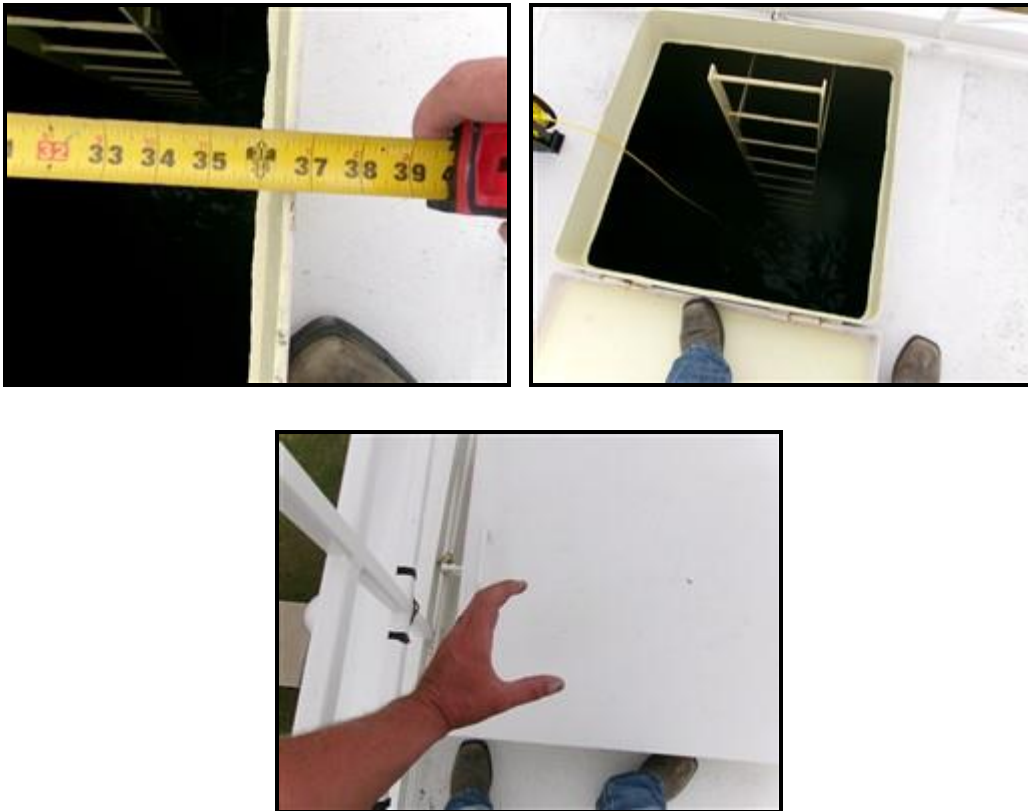
Water Access Hatch:

The steel water access hatch was in good condition. It is located at the twelve o'clock position of the facility on the roof plates and measures 36x 36 inches. The hatch was secured with a combination lock however it was not labeled as a "Confined Space" entry upon the arrival of the inspection crew. **TEXAS TANK SERVICES** recommends installing a "Confined Space" entry placard to the water access hatch.

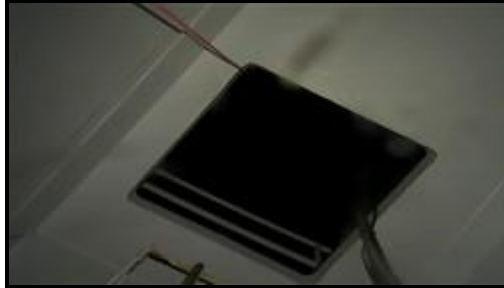
Water Access Hatch:

The water access hatch was in good condition upon internal inspection. No abnormalities were reported.

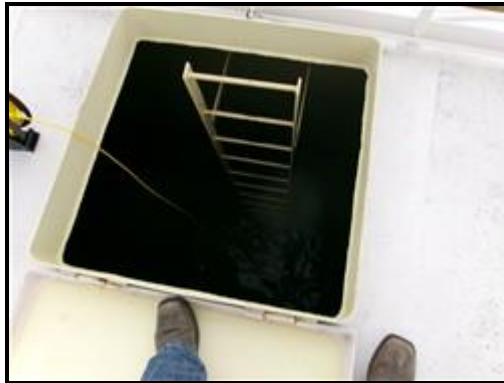
Water Access Ladder:

The water access ladder was in good condition above the water line. It measures 16 inches in width and has rebar $\frac{3}{4}$ inch rungs with 1 foot spacing. This ladder was not equipped with fall protection. Light to moderate staining was noted. **TEXAS TANK SERVICES** recommends installing fall protection on the water access ladder to insure the safety of anyone accessing this component.

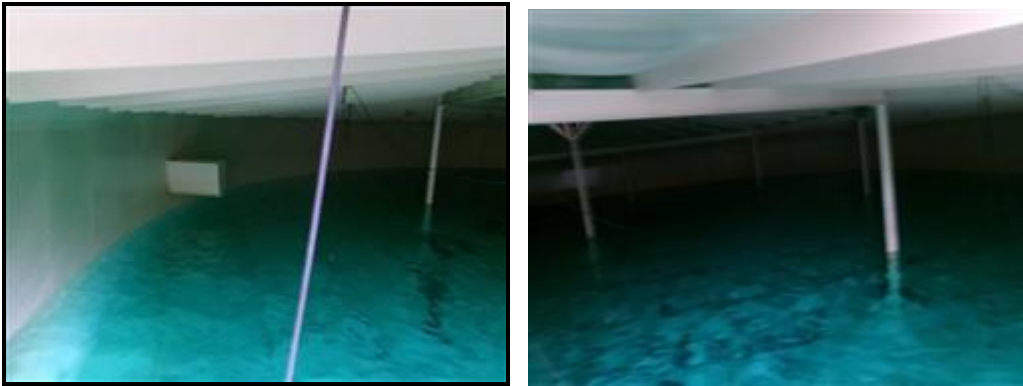
Internal Sidewall Plates:

The internal sidewall plates were in good condition above the water line. No abnormalities were reported.

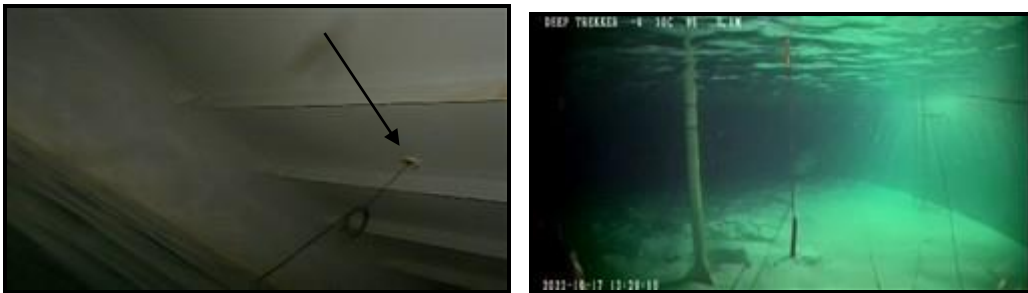
Water Level Indicator Probe:

The water indicator probe was in good condition at the time of inspection. It is located at the one o'clock positions of the facility. Components were in position, and the system was intact. No abnormalities were reported.

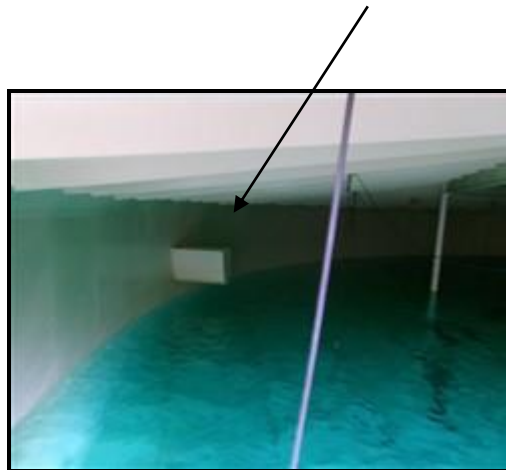
Overflow Flume:

The overflow flume was in good condition. The box style flume is located at the three o' clock position of the facility. Light staining was reported. No other abnormalities were reported.

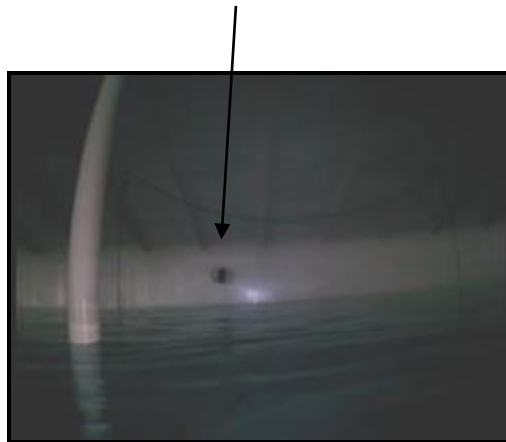
Water Inlet:

The water inlet was inactive and in good condition. It is located at the five o' clock position of the facility and measures 16 inches in diameter. Light staining was reported. No other abnormalities were reported.

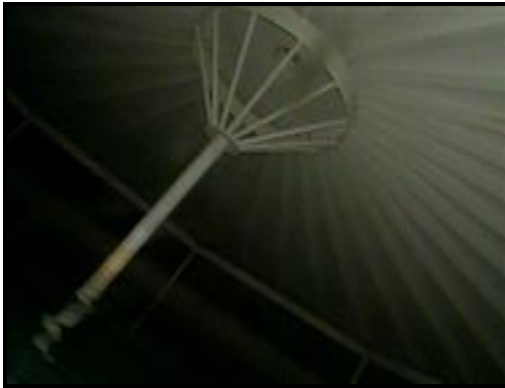
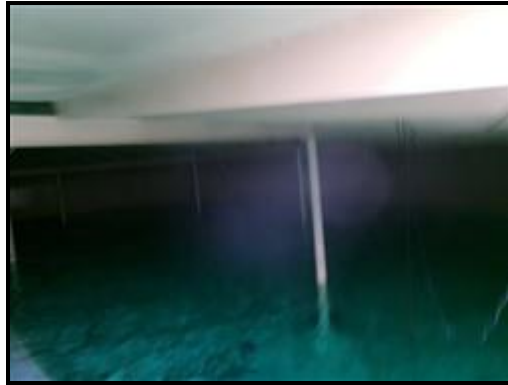
Center Support Column:

The center support column was in good condition above the water line. Light staining was reported. No other abnormalities were reported.

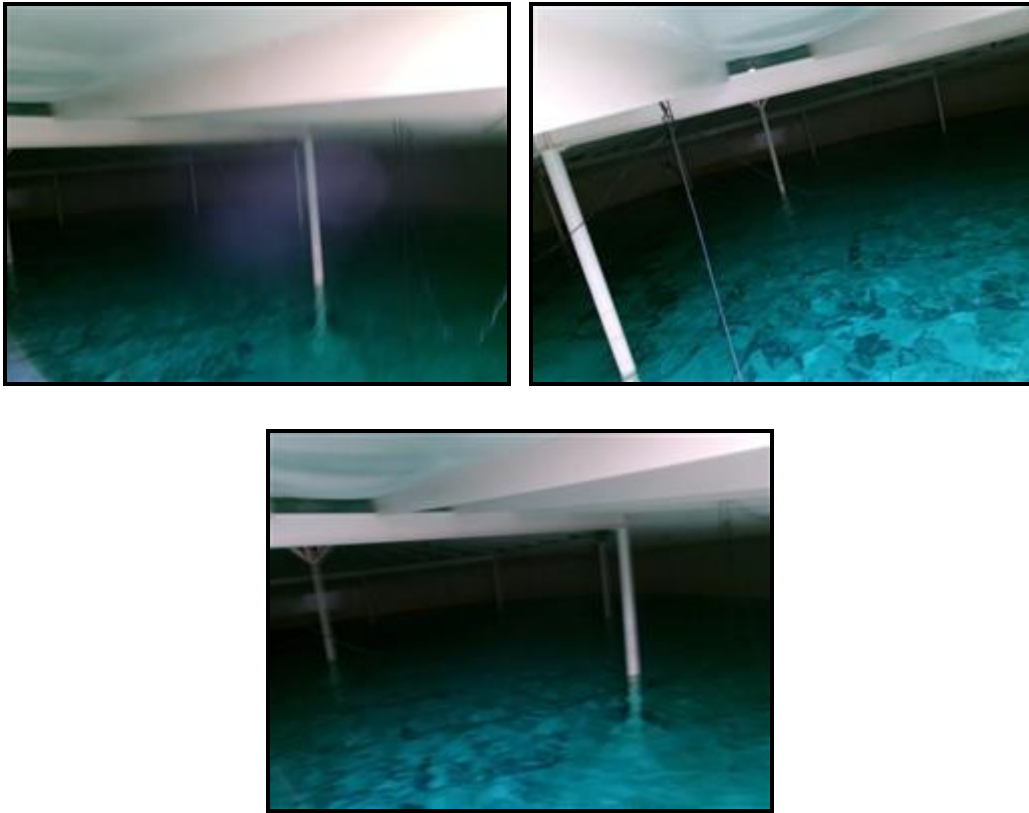
Internal Roof Plates:

The internal roof plates were in good condition. Light condensation was reported. No other abnormalities were found.

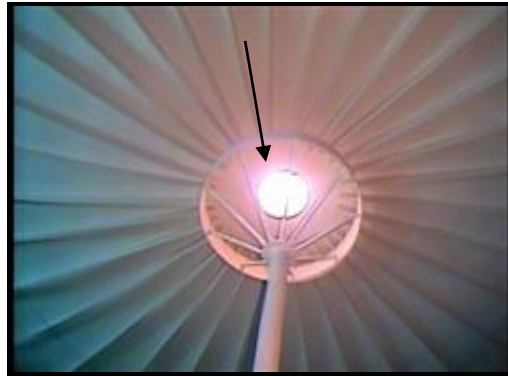
Roof Ventilation Structure:

The roof ventilation structure was in good condition upon internal inspection. It is located in the center of the facility on the roof plates and measures 22 inches in diameter. It is equipped with a 16-mesh screen that is also in good condition. No abnormalities were reported.

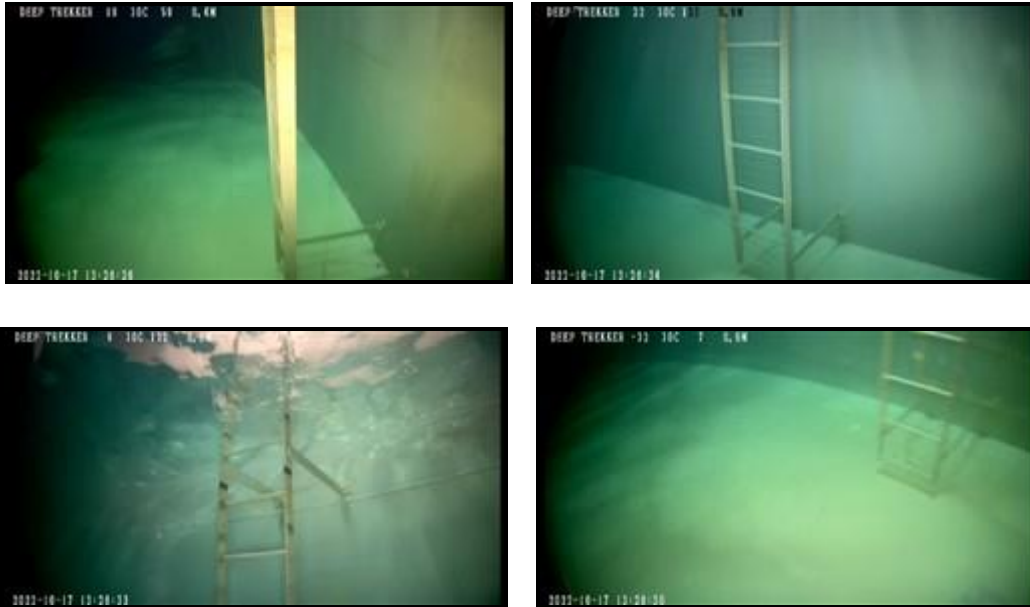
Water Access Ladder (below the water line):

The water access ladder was in fair condition below the water line. It measures 16 inches in width and has $\frac{3}{4}$ inch rungs with 1 foot spacing. The ladder was not equipped with fall protection. Moderate staining and corrosion were reported. **TEXAS TANK SERVICES** recommends machine prepping the corroded areas of the water access ladder and adding a new protective coating. **TEXAS TANK SERVICES also recommends** installing fall protection to the water access ladder to insure the safety of anyone accessing this component.

5. Machine prep the corroded areas of the center access column and water access ladder and adding a new protective coating.
6. Monitor the interior sidewall plates of the facility for additional corrosion and protective coating failure and consider the facility for an interior sandblast and recoat to extend the life of this structure.

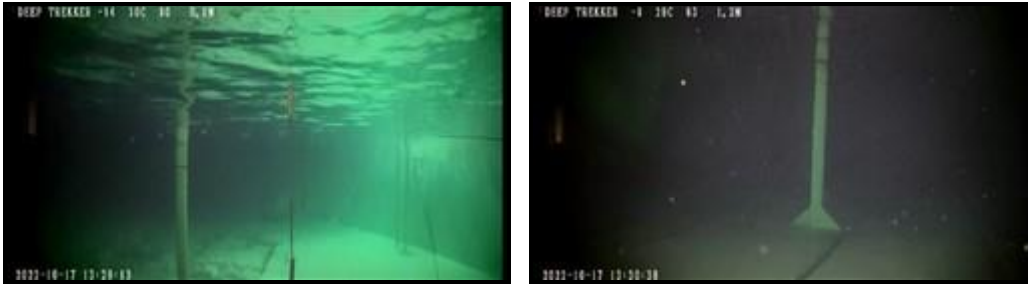
Center Support Column:

The center support column was in good condition below the water line. Light staining and corrosion were reported on the center support column. No other abnormalities were reported. **TEXAS TANK SERVICES** recommends machine prepping the corroded areas of the center access column and adding a new protective coating.

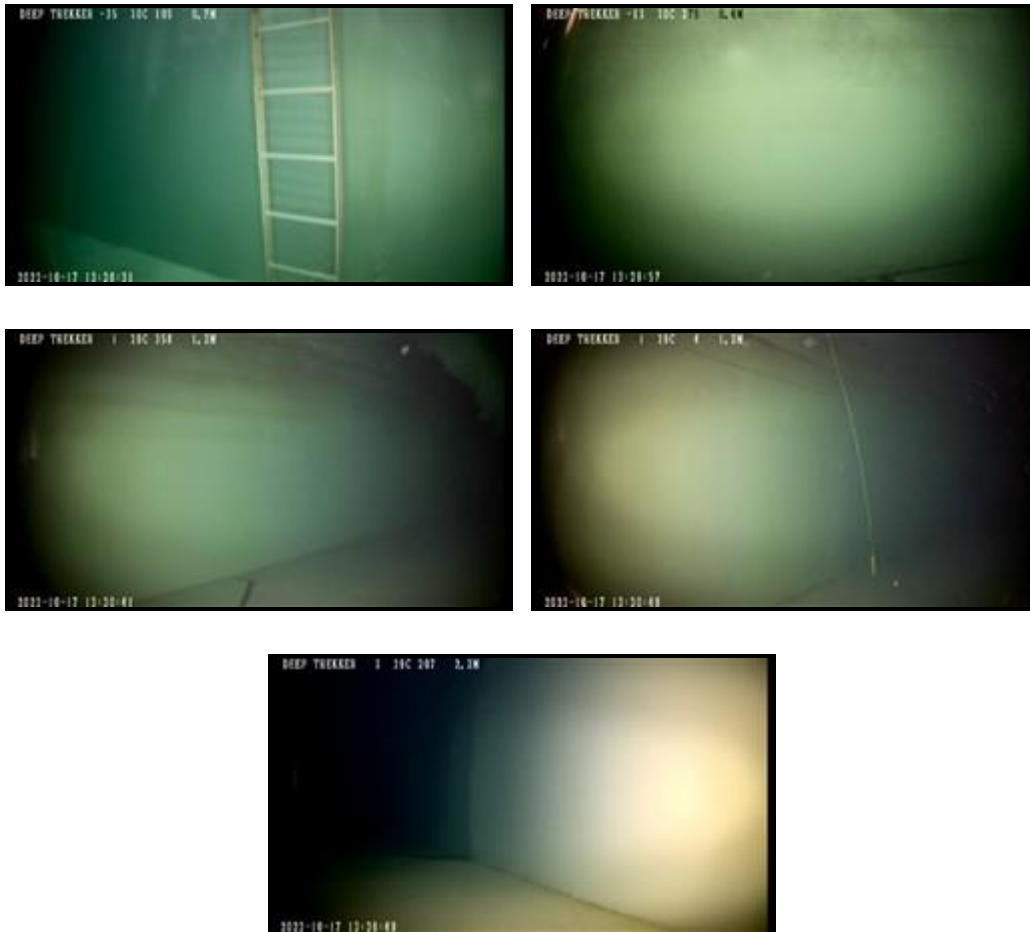
Internal Sidewall Plates:

The internal sidewall plates were in good condition below the water line. Light staining and corrosion were reported. No other abnormalities were reported. **TEXAS TANK SERVICES** recommends monitoring the interior sidewall plates of the facility for additional corrosion and protective coating failure and considering the facility for an exterior sandblast and recoat to extend the life of this structure.

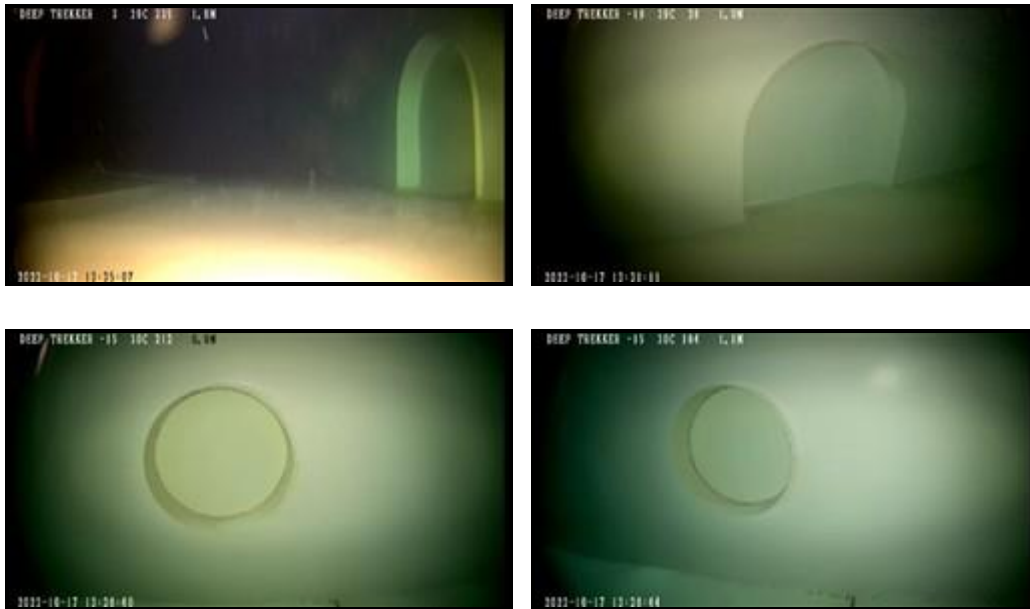
Manway Access Hatches:

The two manway access hatches were in good condition at the time of inspection. They are located at the three and eight o' clock positions of the facility. The gaskets were intact, and no leaking was observed. Light staining was reported. No other abnormalities were reported.

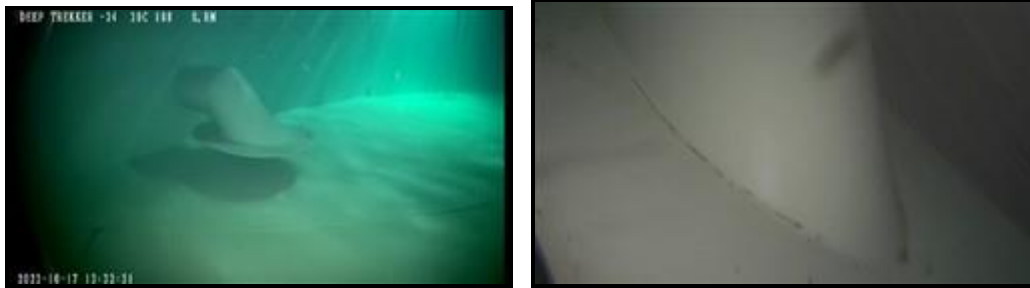
Water Outlet:

The water outlet was in good condition at the time of inspection. It is located at the eleven o'clock position of the facility and is equipped with a safety gate. Light staining was reported. No other abnormalities were reported.

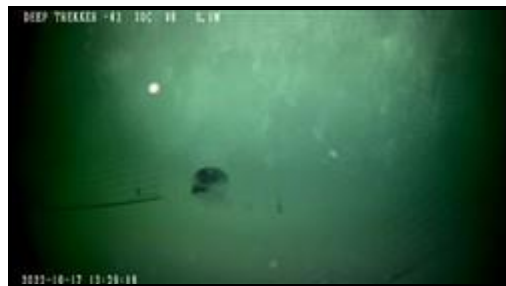
Manual Drain:

The manual drain was in good condition at the time of inspection. It is located at the three o'clock position of the facility. Light staining was reported. No other abnormalities were reported.

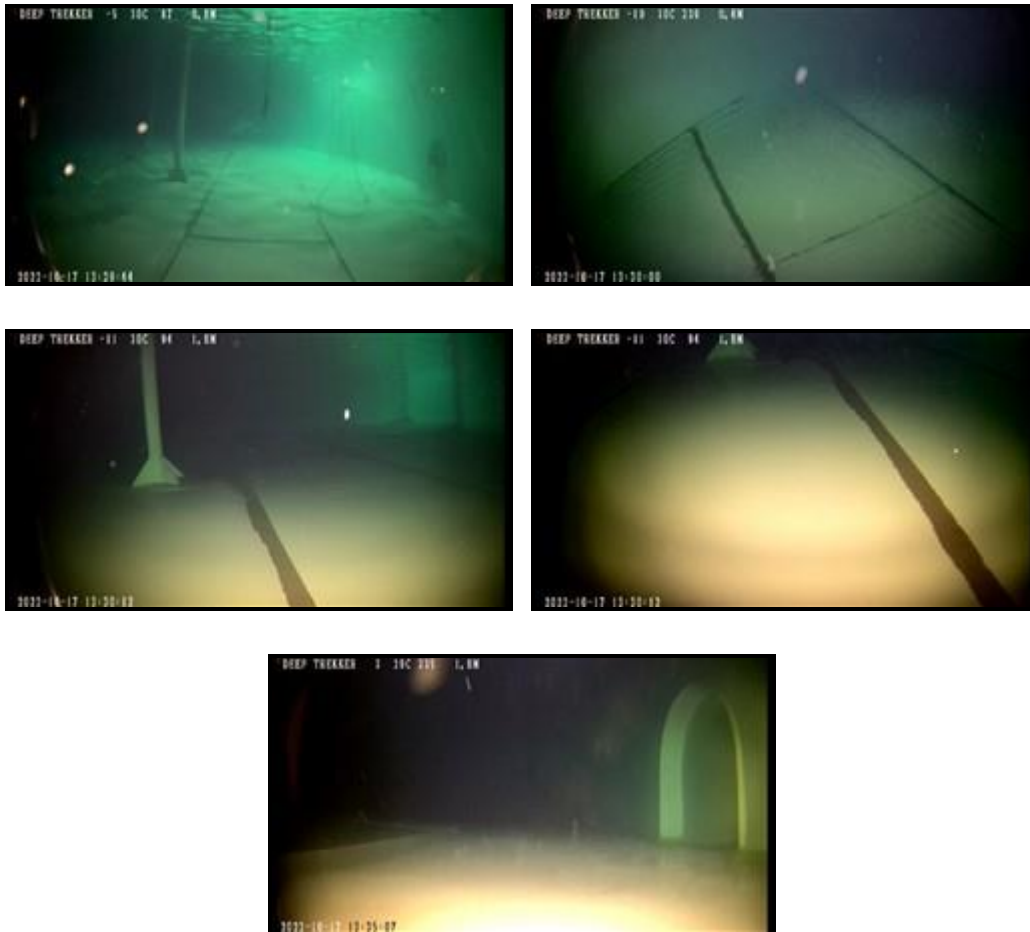
Internal Floor Plates:

The internal floor plates were in good condition at the time of inspection. Light to moderate staining was reported. **TEXAS TANK SERVICES** recommends performing a chemical power wash of the interior of the facility, utilizing Blue Earth Labs' product Floran, to remove staining and extend the life of this structure.

7. Perform a chemical power wash of the interior of the facility, utilizing Blue Earth Labs’ product Floran, to remove staining and extend the life of this structure.

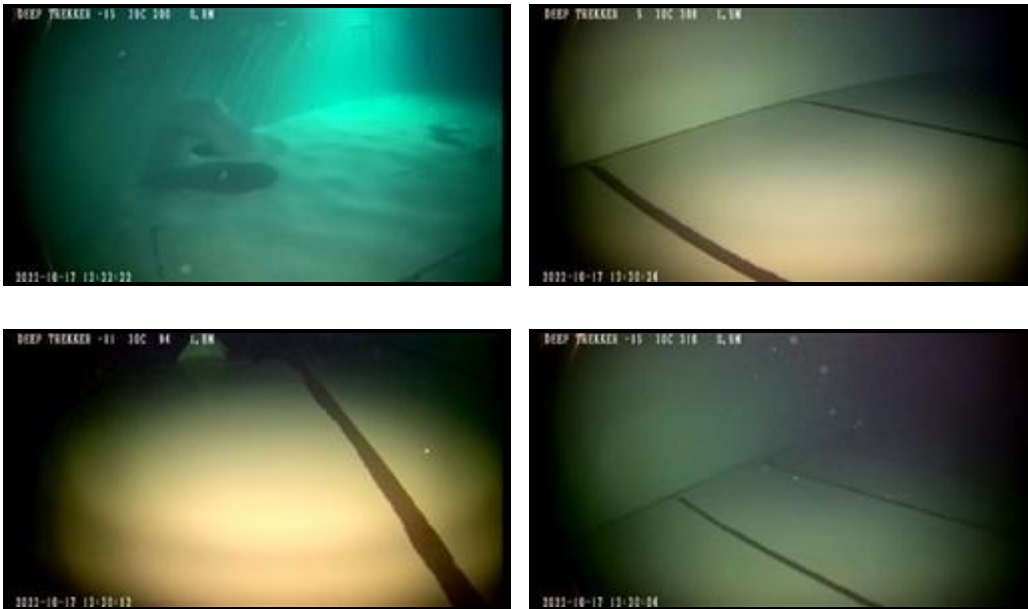
Sediment Depth:

The sediment depth was reported as a heavy dusting consisting of sand. **TEXAS TANK SERVICES** recommends an in-service cleaning to remove this sediment in order to better evaluate the floor plates, as well as improve the quality of the water in this tank.

2. Perform an in-service cleaning on this facility. Removal and discharge of all sediment should improve the water quality as well as extend the life of this facility.
